**THE CAUSES OF BUILDING DEFECTS IN APOWA IN THE  
AHANTA WEST DISTRICT OF GHANA**

**A dissertation submitted to the Department of CONSTRUCTION AND  
WOOD TECHNOLOGY EDUCATION, Faculty of TECHNICAL  
EDUCATION submitted to the School of Graduate studies, University of  
Education, Winneba in partial fulfilment of the requirements for the  
award of Masters of Technology (Construction) degree**

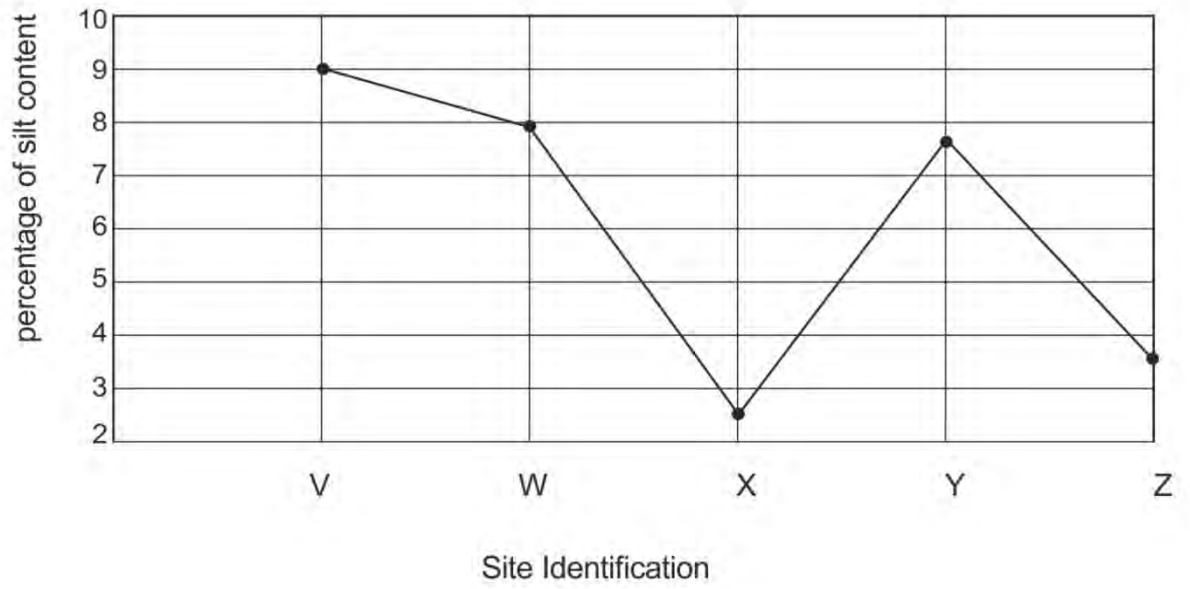
Figure 1: Silt test performed on sand

Sample V recorded a sand settlement of 110ml and a silt settlement of 120ml giving 9.1% silt content. Sample W also recorded 117ml and 126ml for sand and silt settlements respectively resulting in 7.7% silt content. The sample obtained from site X provided a silt content of 2.6% from sand and silt settlements of 115ml and 119ml respectively. The sample got from site Y were 7.5% silt content, a sand settlement of 120ml and 129ml of silt settlement. The results obtained sample Z also provided a sand settlement of 115ml and silt settlement of 119ml resulting in 3.5% silt content in the sand.

Seeley (1996) advises that, silt in sand for building works should not be more than 6%. From the laboratory test conducted, and shown on figure 1, three of the samples V, W and Y recorded excessive 7.7% to 9.1% silt content. This also contradicts Anevordzie (1997) who recommends that, sand from buildings should be clean and free from excessive silt and chemical properties.
