**ASSESSING THE LEVEL OF COMPLIANCE TO THE BUILT-INFRASTRUCTURE
PROVISIONAL REQUIREMENTS OF THE DISABILITY ACT, 2006 (ACT715)
AMONG PROFESSIONALS WITHIN THE BUILT ENVIRONMENT IN THE KUMASI
METROPOLIS**

MASTER OF PHILOSOPHY

2019

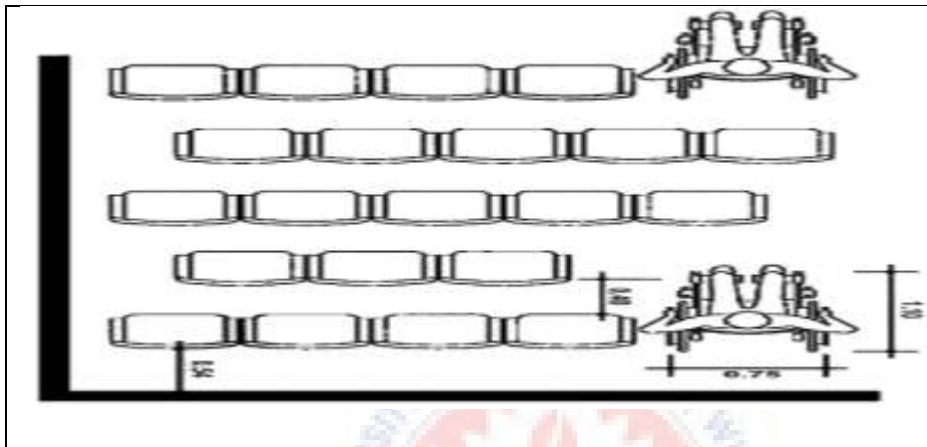
Some seats with removable or flip-up armrests should be provided at each row end in order to accommodate a wheelchair user or a person with limited ambulatory mobility. A level floor area for wheelchair users should be placed at row ends and should be scattered on different levels so as to have a variety of seating and viewing locations. (McClain-Nhlapo, 2006). Figure 2.3 shows a display of variety of seating and viewing locations for wheel chair users at each row end.

Fig 2.2: Variety of seating and viewing locations for wheel chair users at row ends

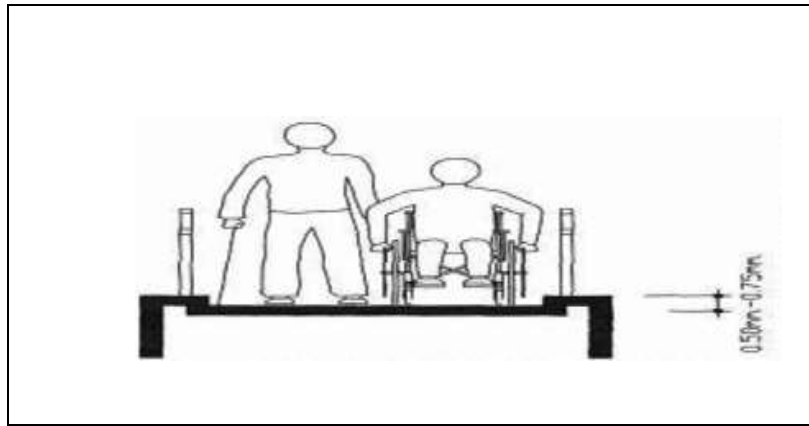
Fig 2.18: Low handrails and curb mounted to guide the disabled (Source: SOLIDERE, 2004)

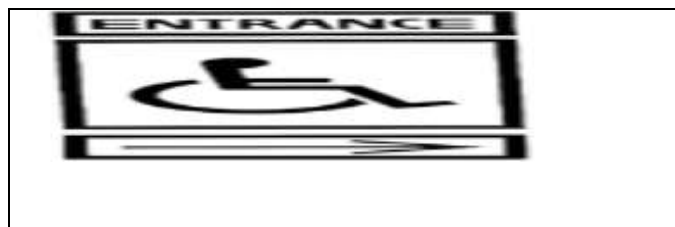
Fig. 2.22: Disables accessibility entrance signage. (Source: SOLIDERE, 2004)

In multi-storey buildings, the accessible entrance should permit access to a conveniently located accessible elevator or lift. Accessible entrances should be clearly identified using the international symbol of accessibility including alternate locations of accessible entrances (figure 2.22) (SOLIDERE, 2004).

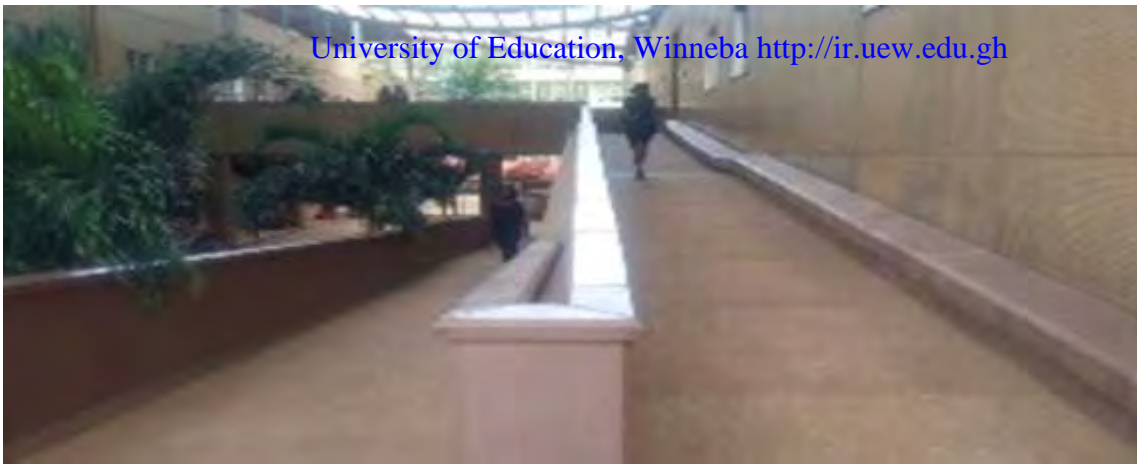
Fig 4.4 Access route at the Accident and Emergency Center of Okomfo Anokye Teaching Hospital, Kumasi is disability friendly (Source: field survey 2018)

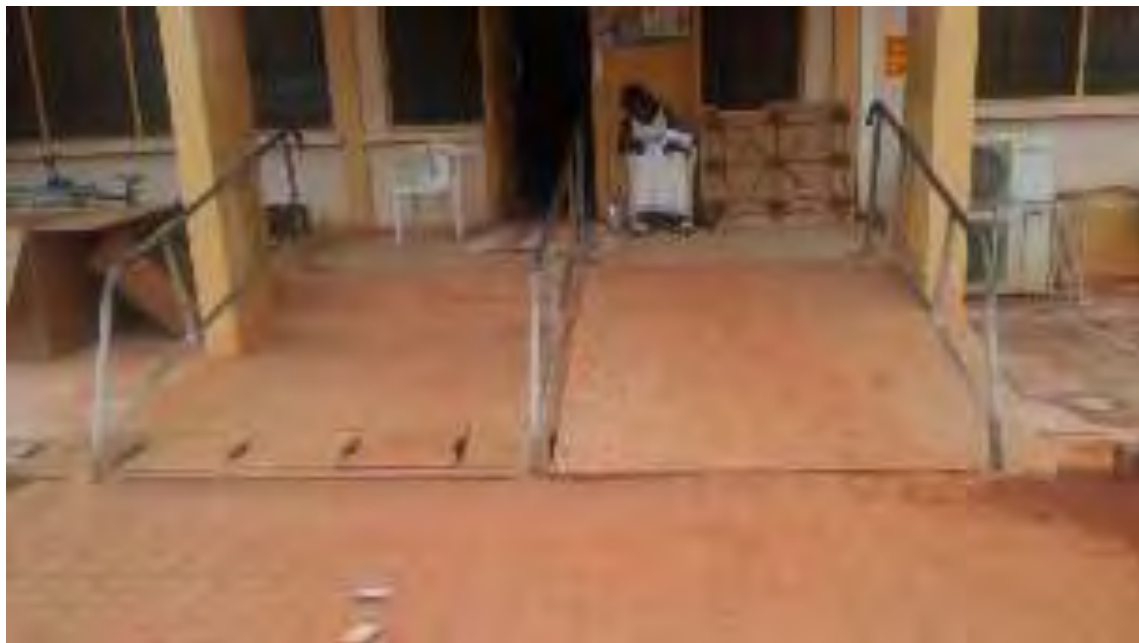
Fig.4.5. The main entrance of the physiotherapy unit at Okomfo Anokye Hospital, Kumasi meets standard requirements prescribed by the disability Act (Source: field survey 2018)

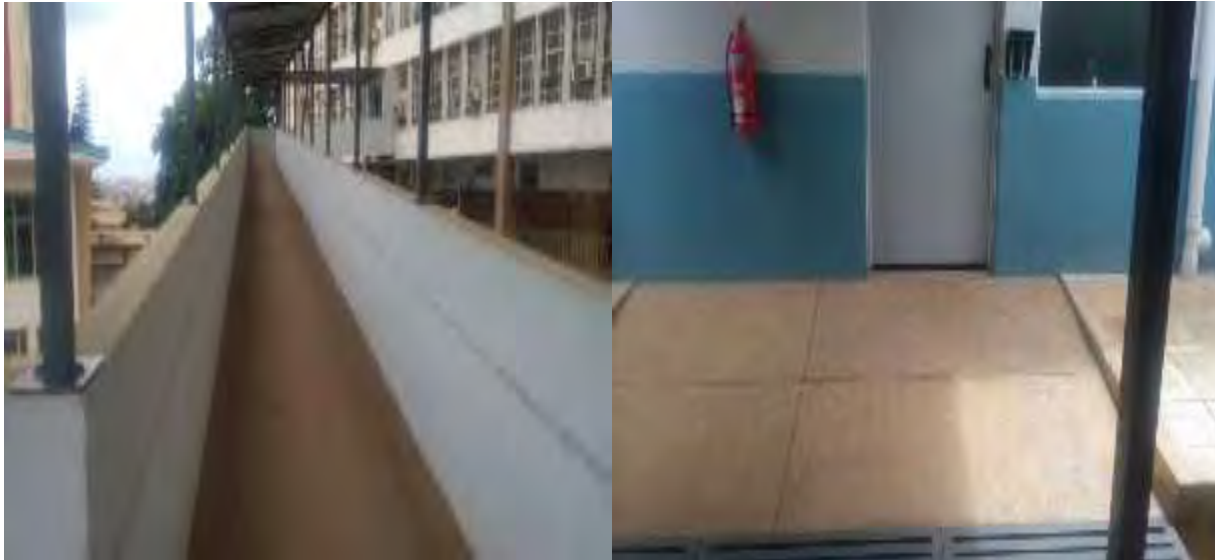
Fig 4.6 Entrance and access routes of Mother and Baby unit constructed more recently is disability friendly (Source: field survey 2018)

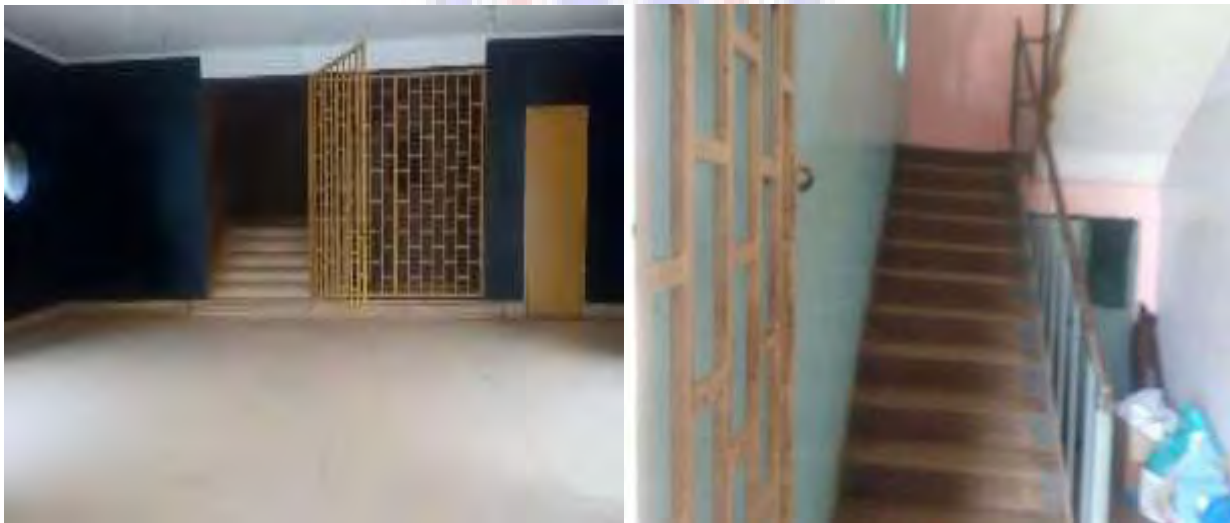
Fig 4.7 These stairs are the access route to upper floors in the blocks A, B, C and D of the health facility are not accessible to the physically challenged (Source: field survey 2018)

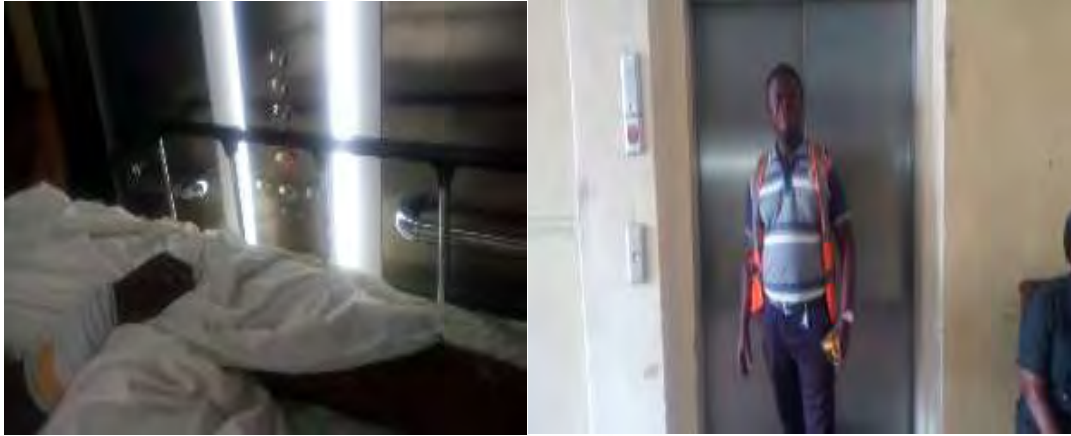
Fig 4.8 Majority of the elevators in A, B, C and D blocks are nonfunctional. A source of worry for the physically challenged. (Source: field survey 2018)

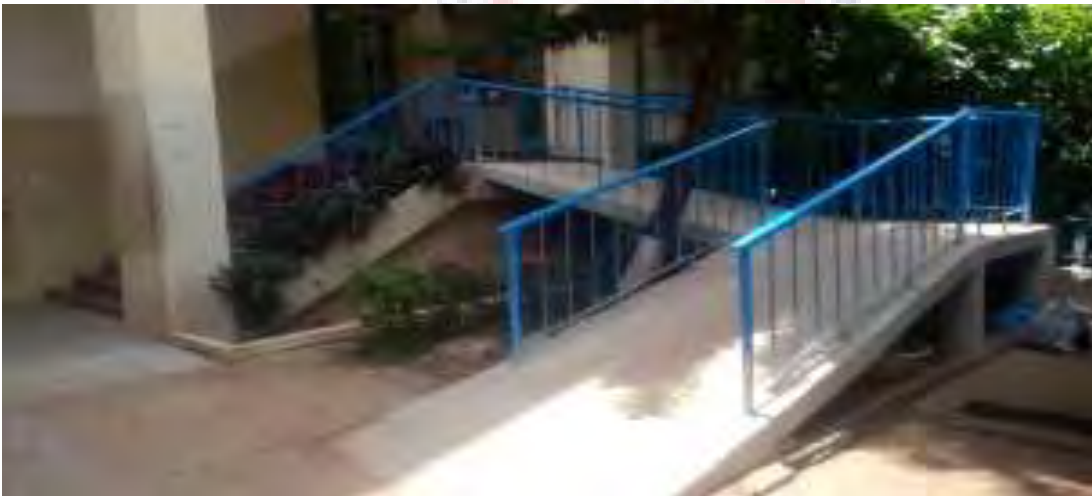
Fig 4.9 The gradient for this ramp constructed recently ear nose and throat center of KATHHT is too steeply (Source: field survey 2018)

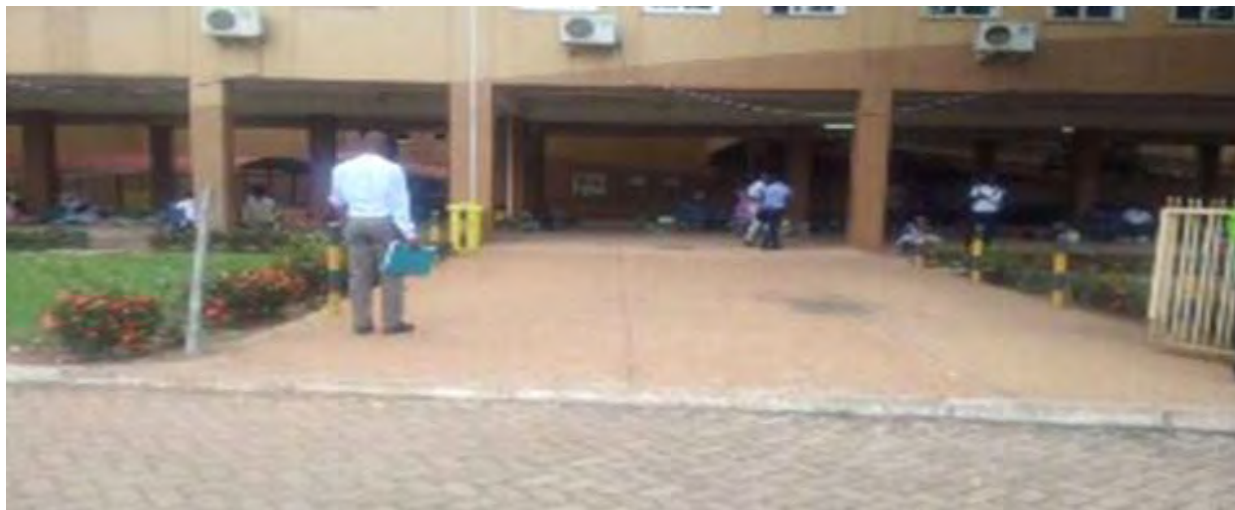
Fig 4.10 The car park and linkages to buildings at accident and emergency center of the KATH are not accessible to the disable (Source: field survey 2018)

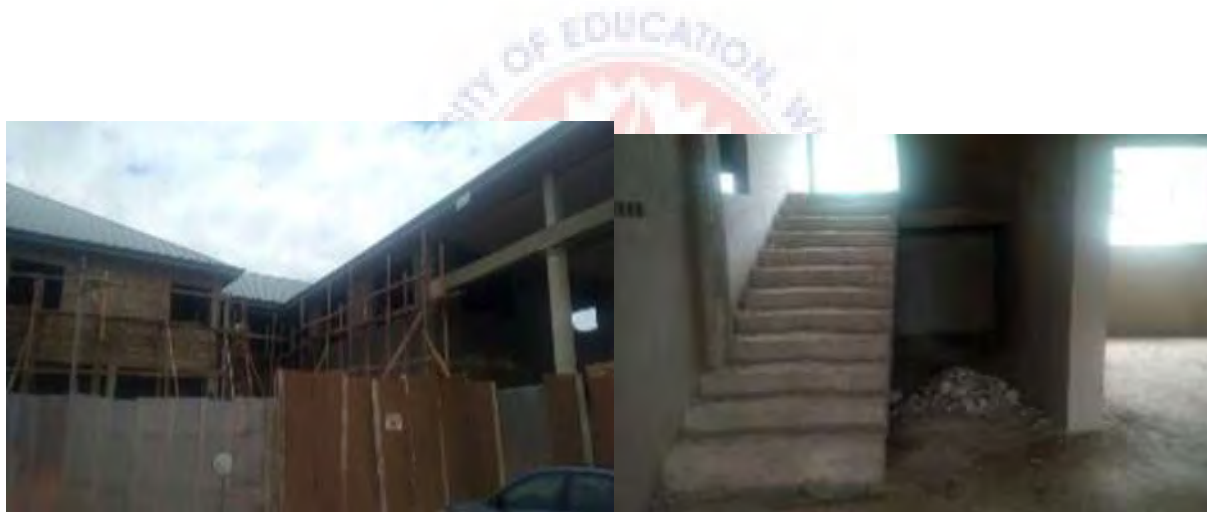
Fig 4.11 This building under construction at the KATH is without access route for the disabled (Source: field survey 2018)

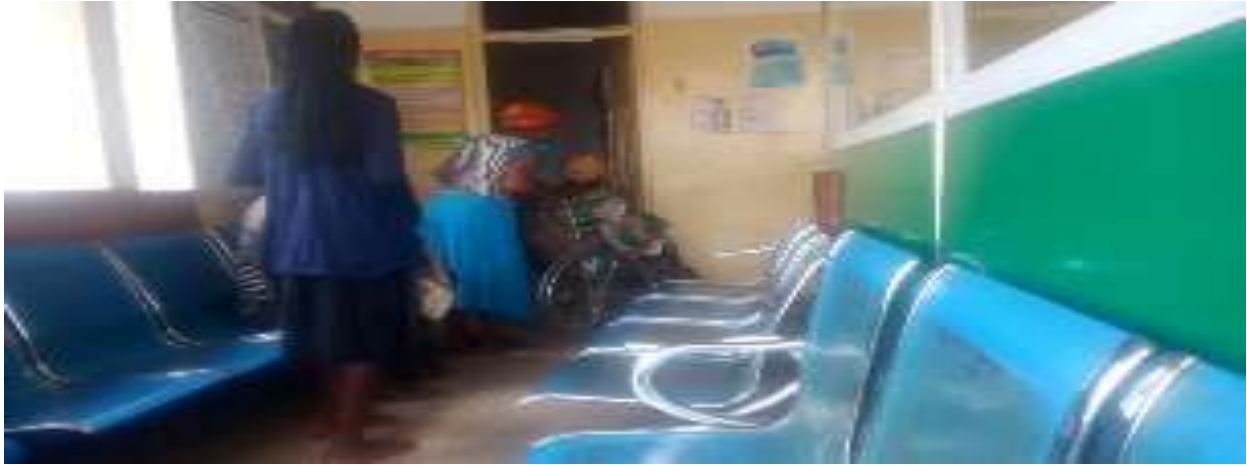
Fig 4.12: Entrance to consulting rooms in Sunteso hospital lack adequate ramp at the entrance. (Source: field survey 2018)

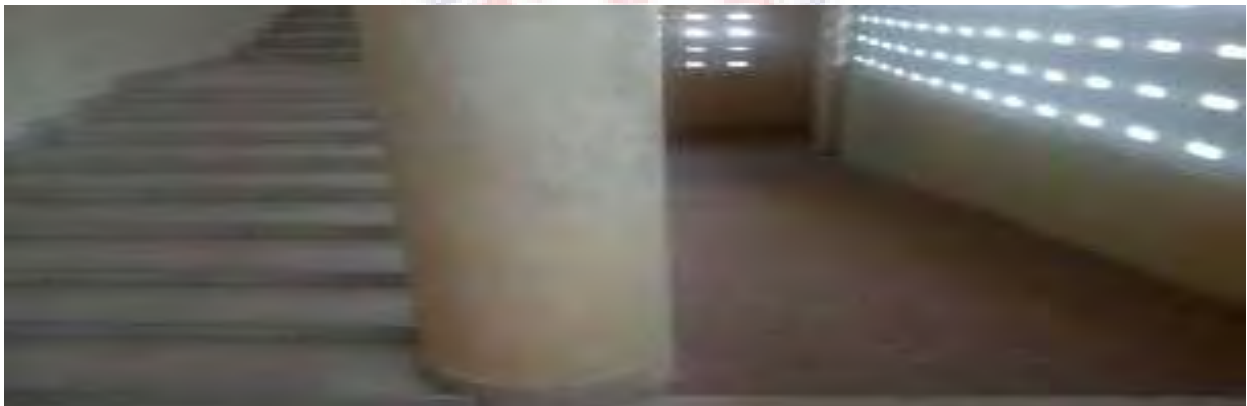
Fig4.13: The Male ward in Sunteso hospital has ramp along the steps and ramp housed in the stairwell up to the first floor. (Source: field survey 2018)

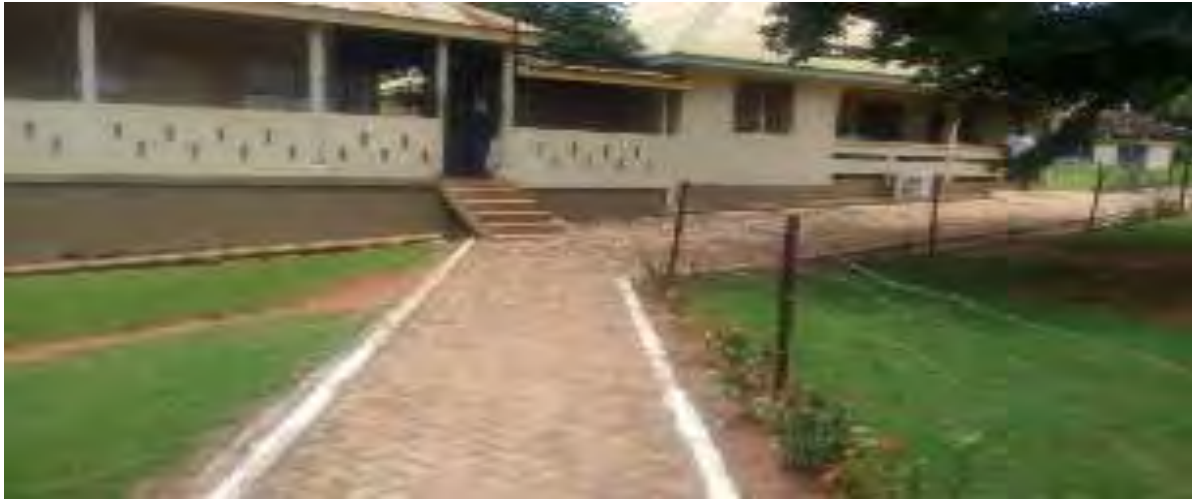
Fig 4.14: The materials center in the Suntreso hospital lacks ramp. (Source: field survey 2018)

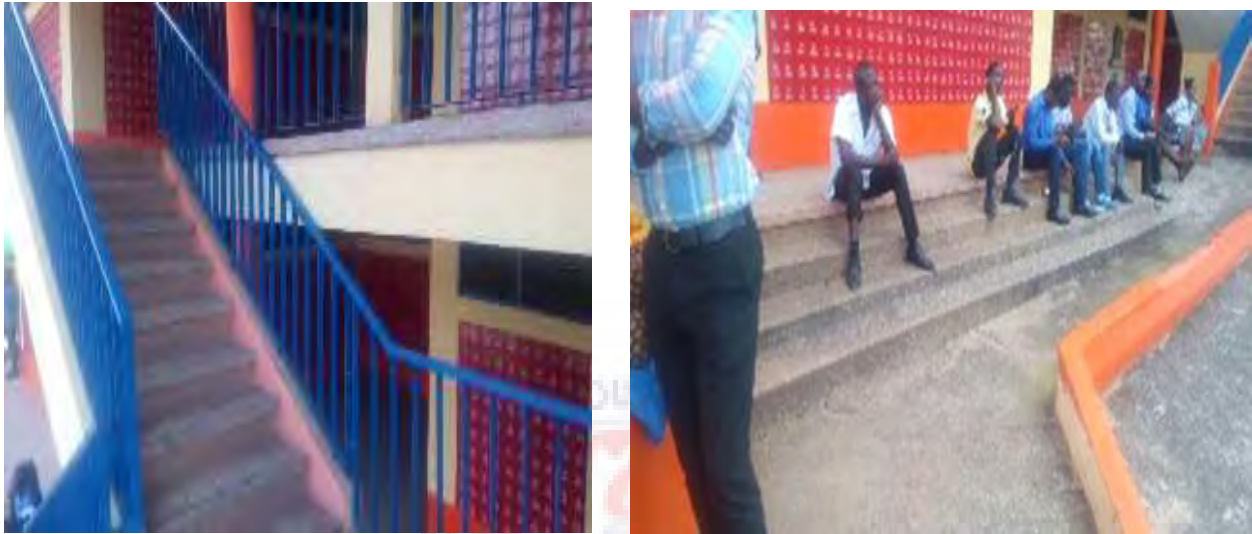
Fig4.15: The Adum Post Office, Kumasi lacks provision for the disable to easily access the mail box (Source: field survey 2018)

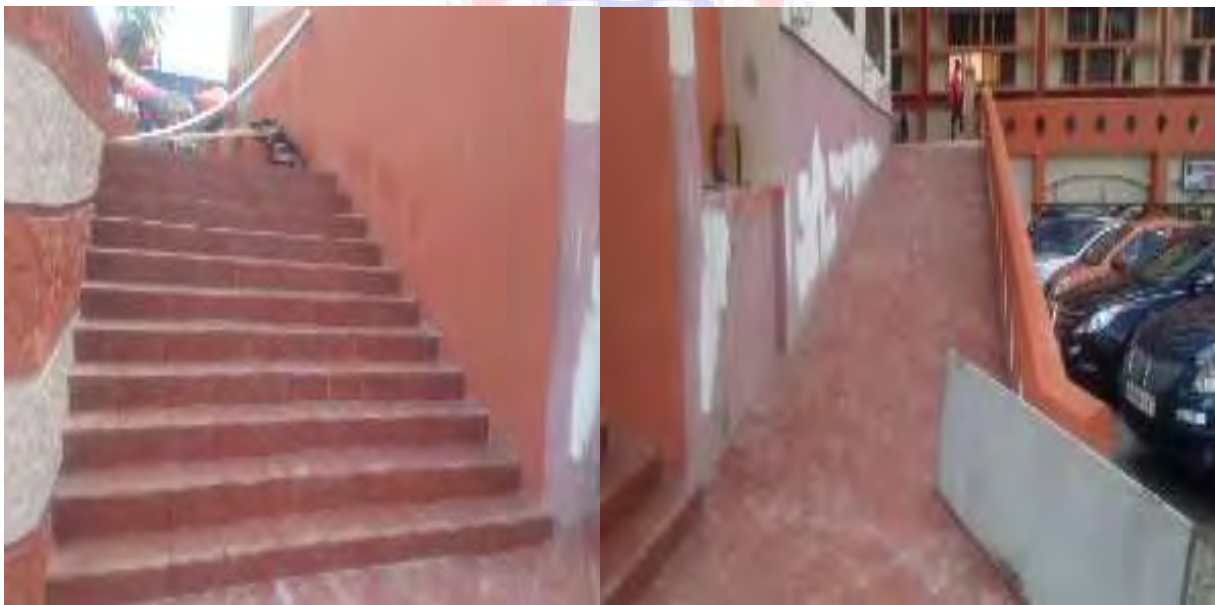
Fig 4.16: The ramp at Main entrance at the Electricity Company at Adum, Kumasi is too smooth and steep for the disable (Source: field survey 2018)

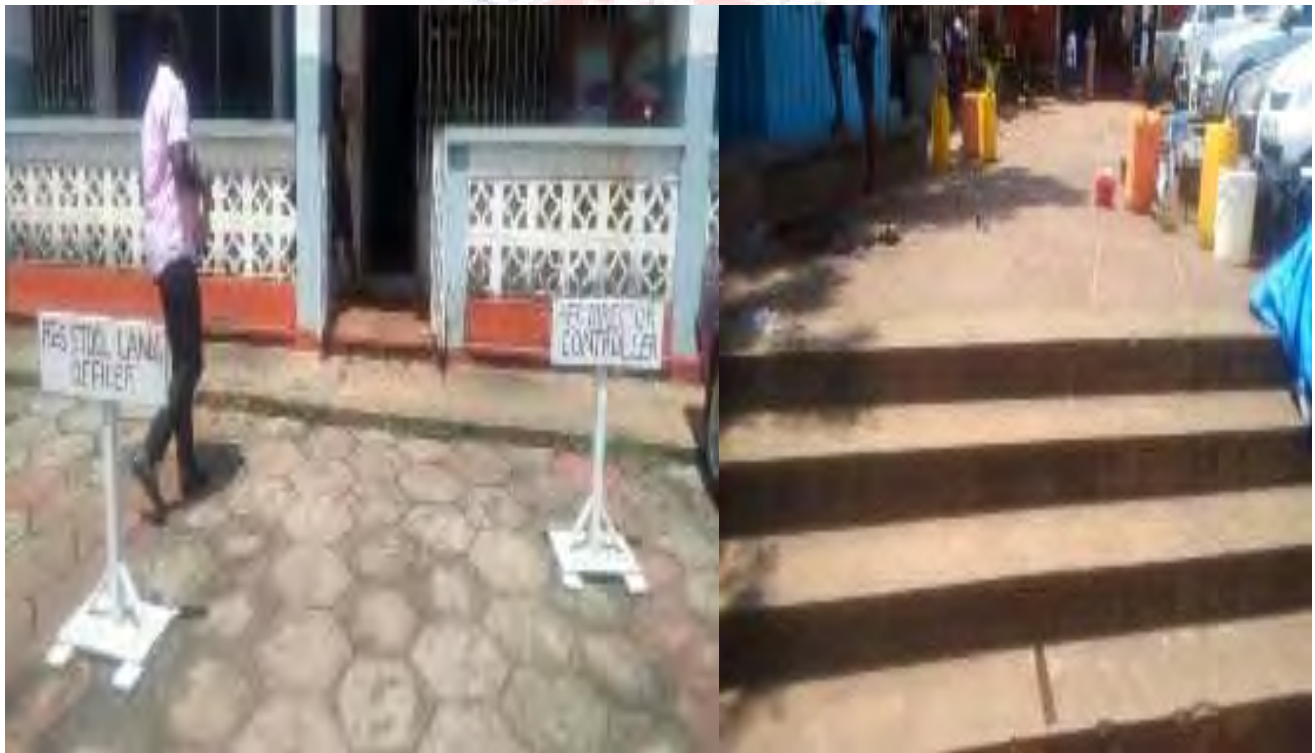
Fig 4.17: Entrances to the buildings at the Kumasi ministries lacks provisions for per persons with disability (Source: field survey 2018)

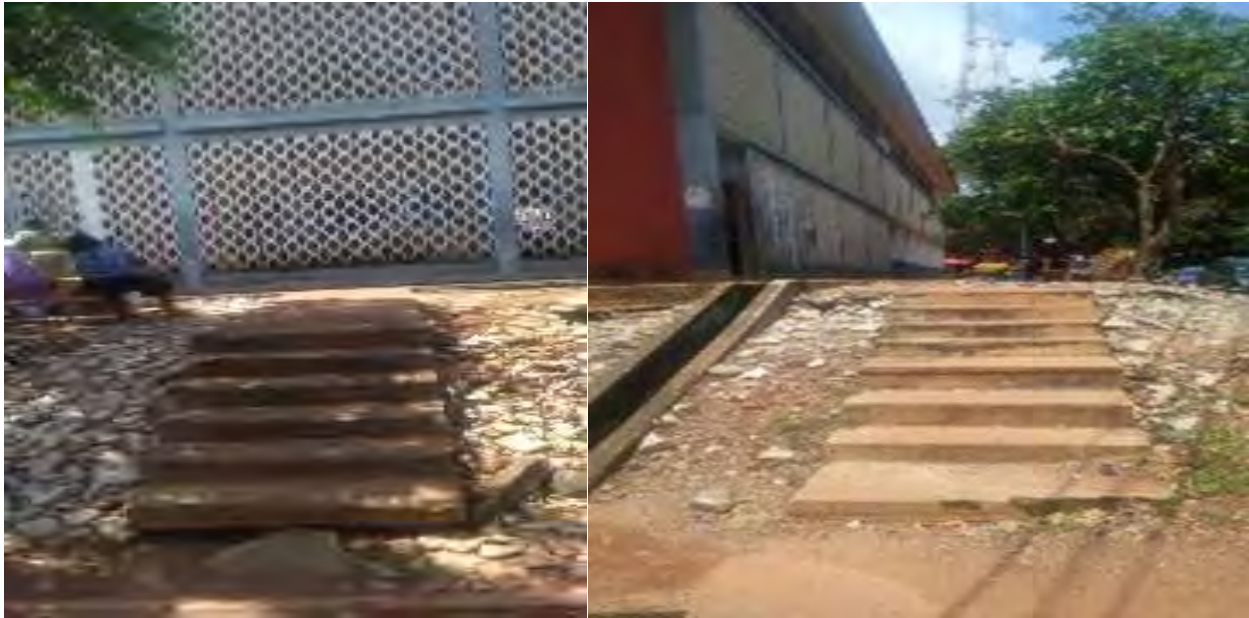
Fig 4.18: These entrants at the Adum Ministries is dilapidated and dangerous to the users including the disabled persons (Source: field survey 2018)

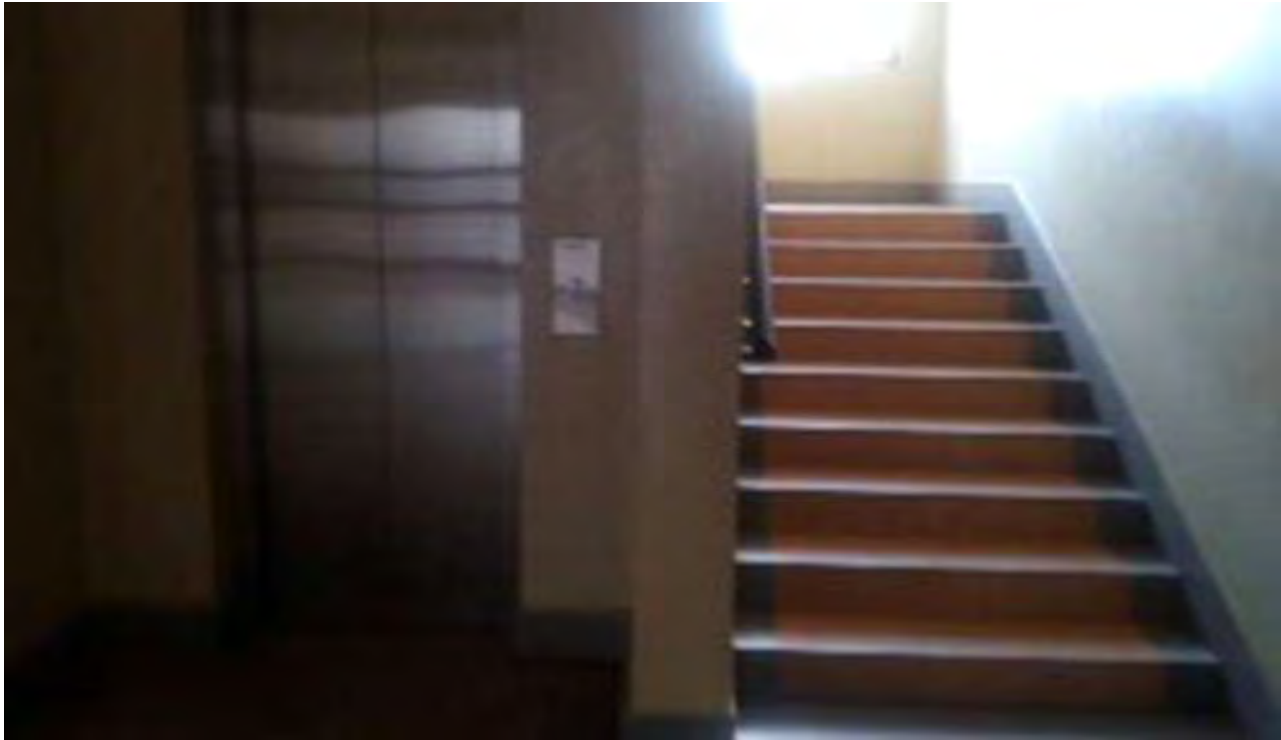
Fig 4.18a: The elevator at the legal aid building, Kumasi is faulty.

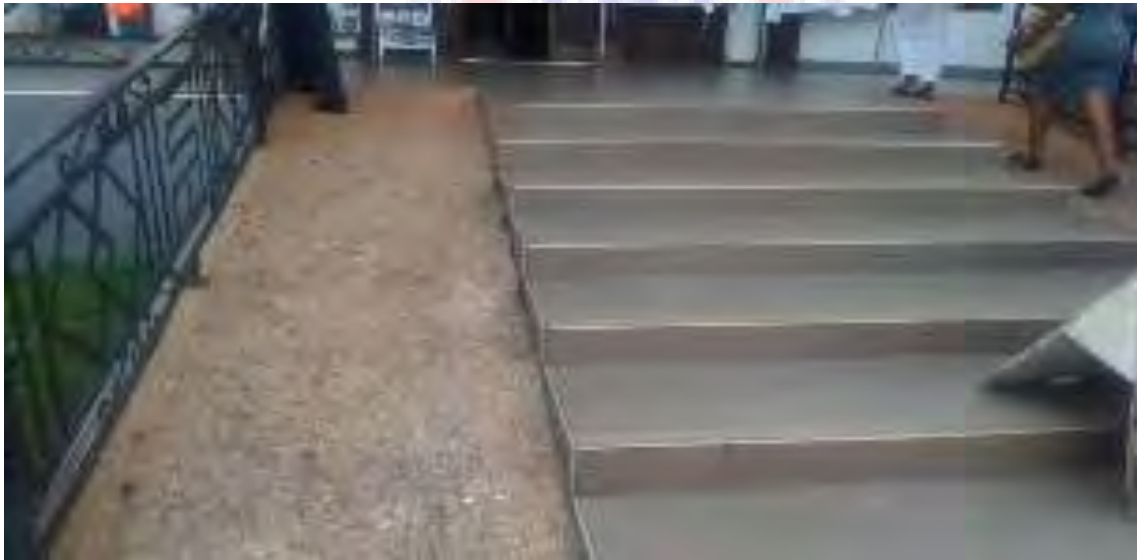
Fig 4.18b: This ramp at the entrance of the legal aid building, Kumasi is too narrow in width and steeply for comfortable of the disabled (Source: field survey 2018)

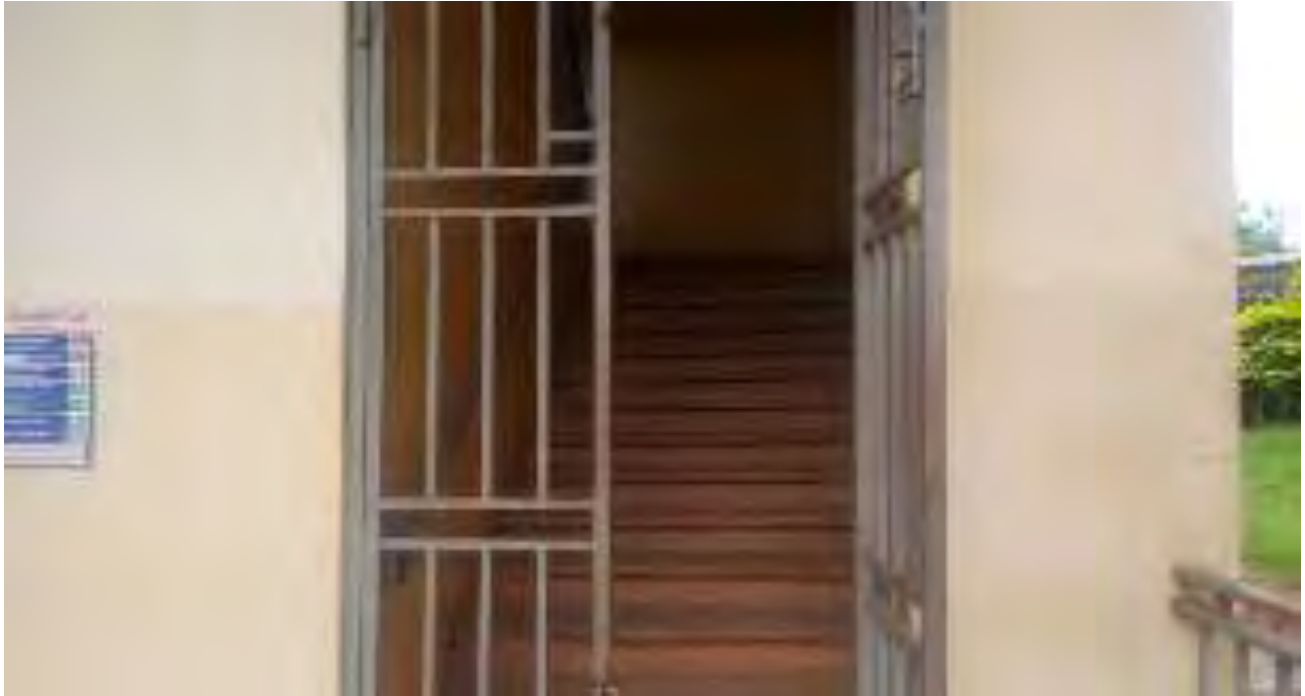
Fig 4.19: The Library, Computer lab and lecture block of the EUW, Kumasi lacks provisions for vertical and are only accessible through stair. (Source: field survey 2018)

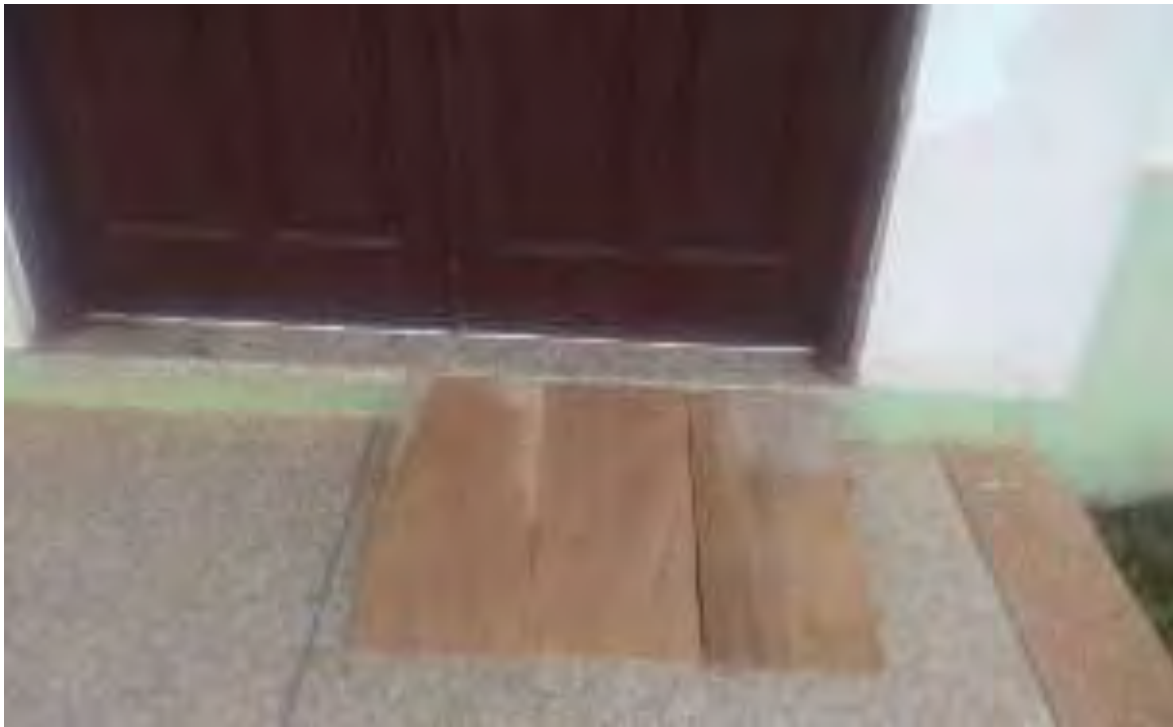
Fig 4.20: This temporary placed at the access route to the new auditorium to make accessible to the disable is inadequate. (Source: field survey 2018)

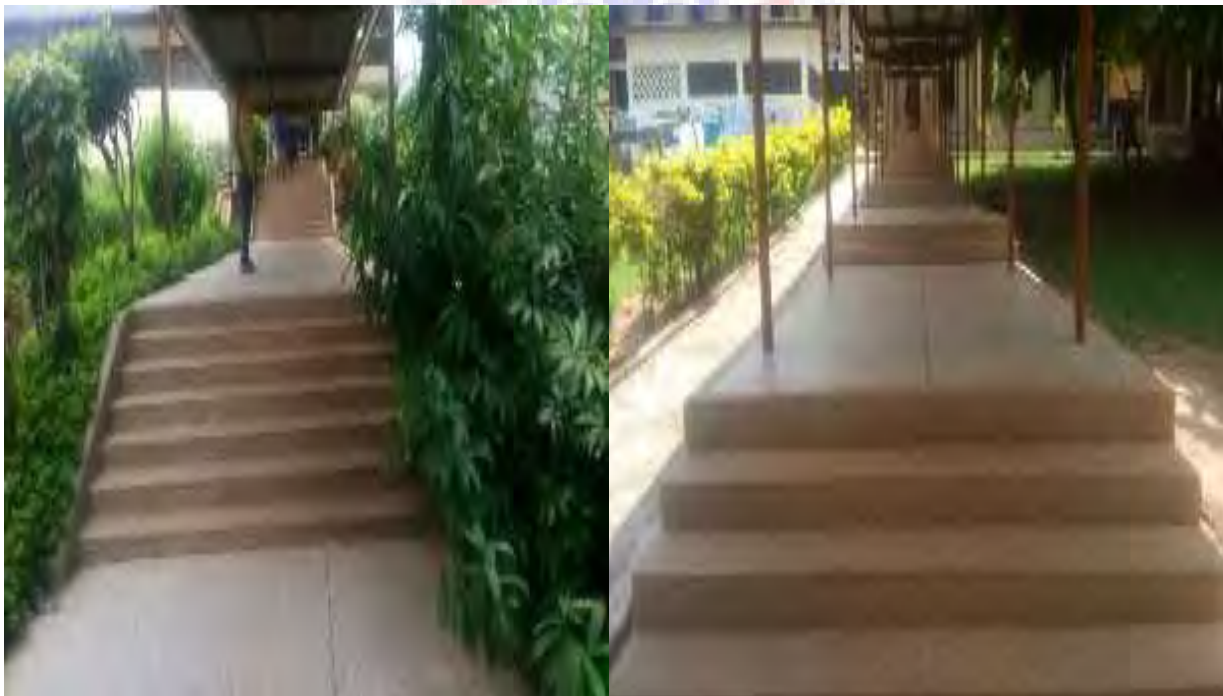
Fig 4.21: These walkways at institutions UEW- Kumasi are not friendly to the disable. (Source: field survey 2018)

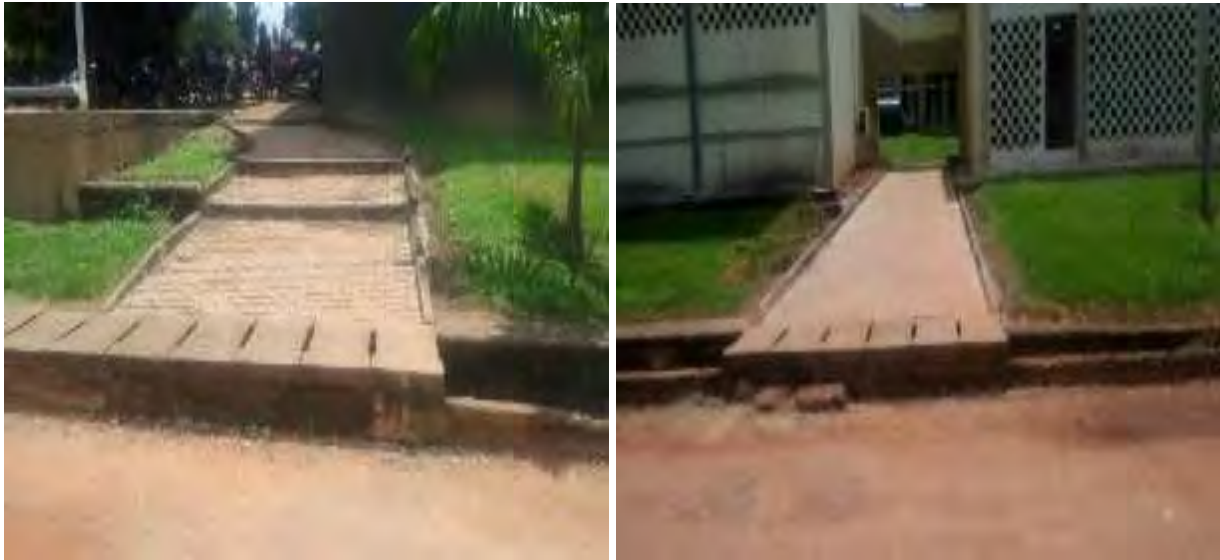
Fig 4.22: There is no provision for Persons with disability to Access the entrance at the Opoku Ware Hall at the UEW- Kumasi (Source: field survey 2018)

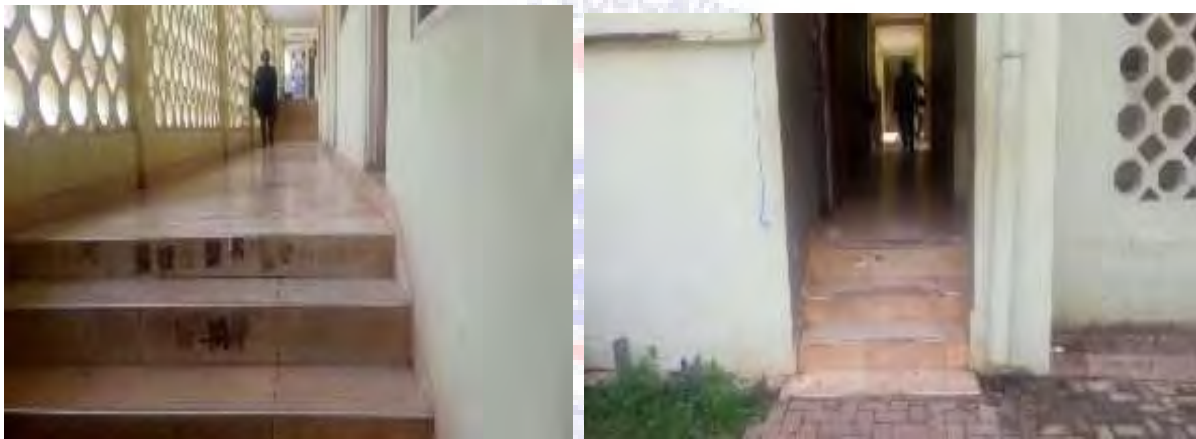
Fig 4.23: Corridors to the Opoku Ware Hall lacks provision to the disabled. (Source: field survey 2018)

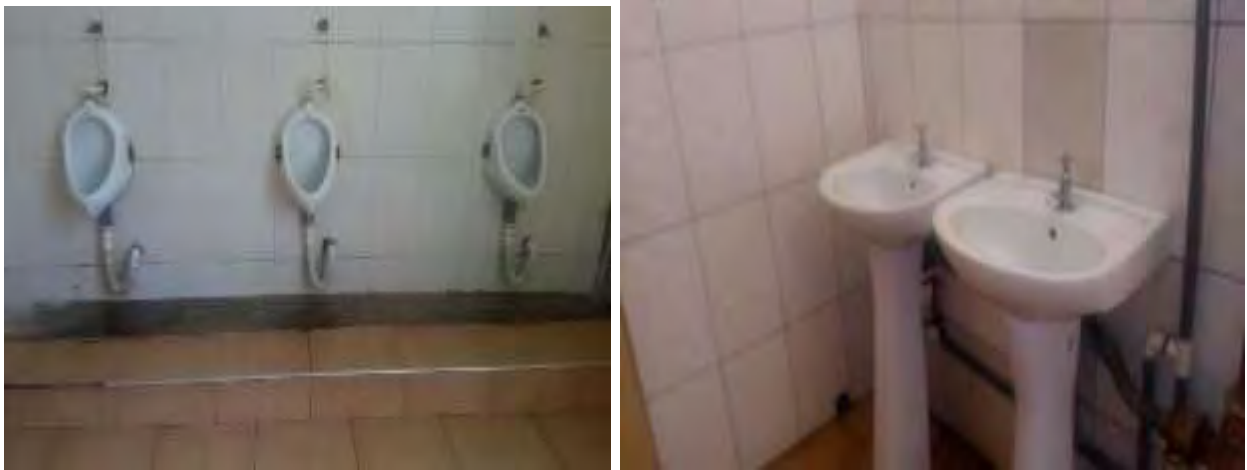
*Fig 4.24: Washrooms at the UEW-Kumasi lacks provisions for the physically challenged
(Source: field survey 2018)*

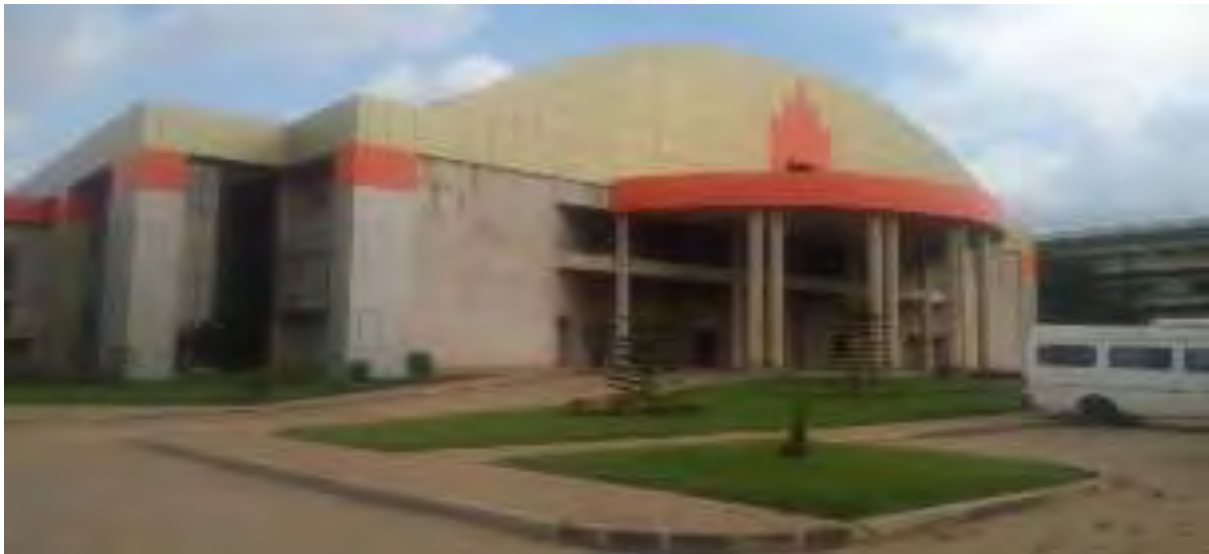
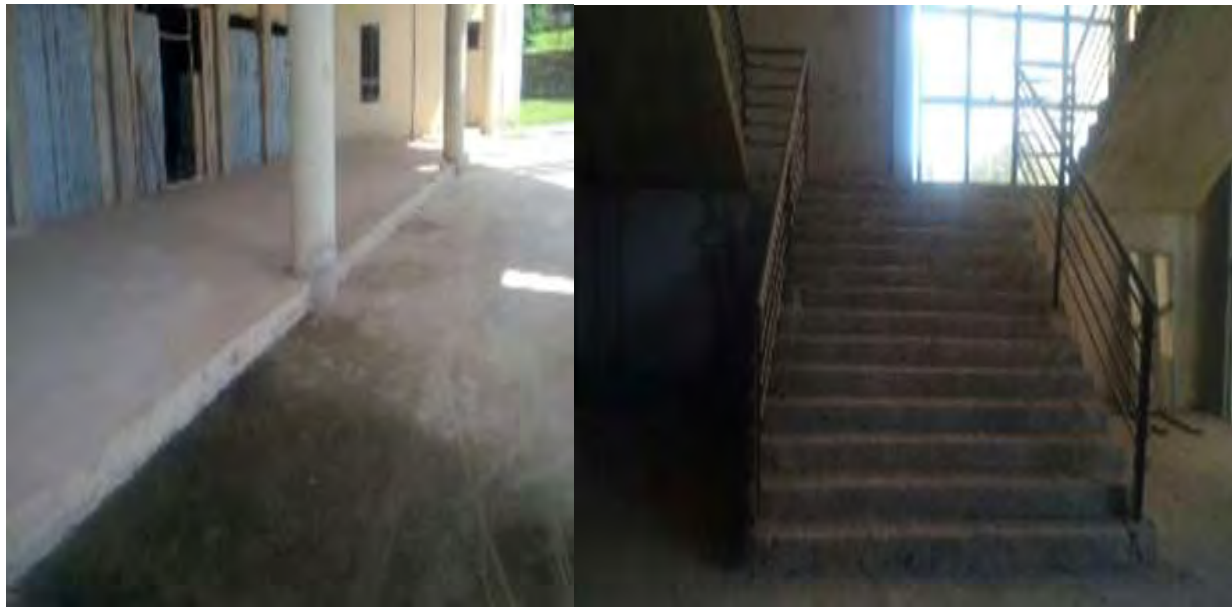
Fig 4.25: The main entrance and interior of the auditorium building under construction at UEW-Kumasi lack provision for the disabled (Source: field survey 2017)

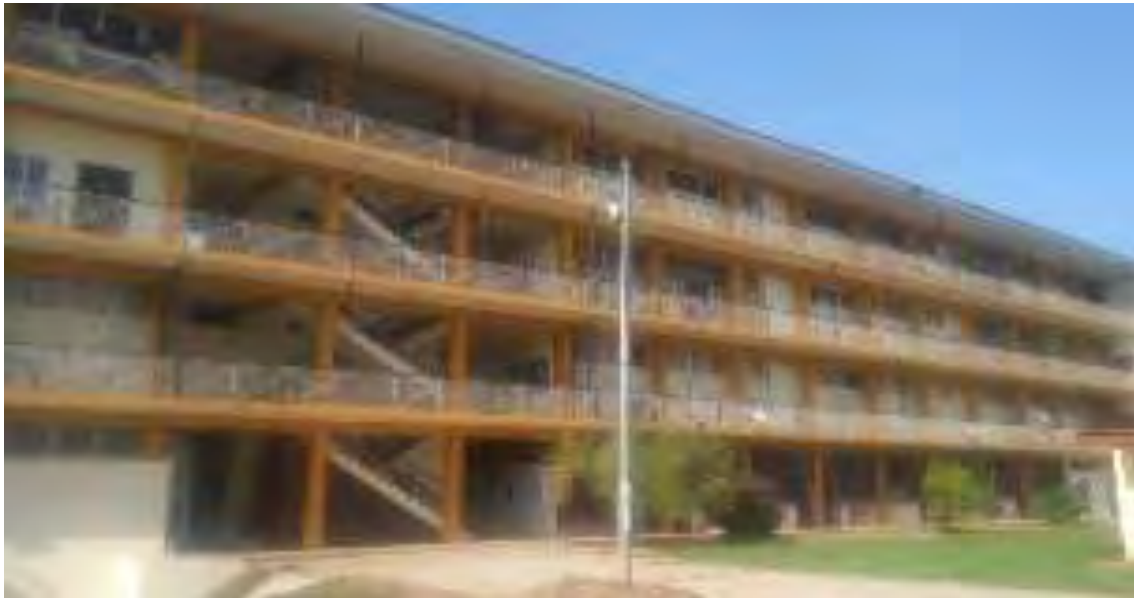
Fig 4.26: Faculty of Social Sciences building at KNUST, Kumasi. Lacks provisions for both horizontal and vertical movement for the disabled (Source: field survey 2018)

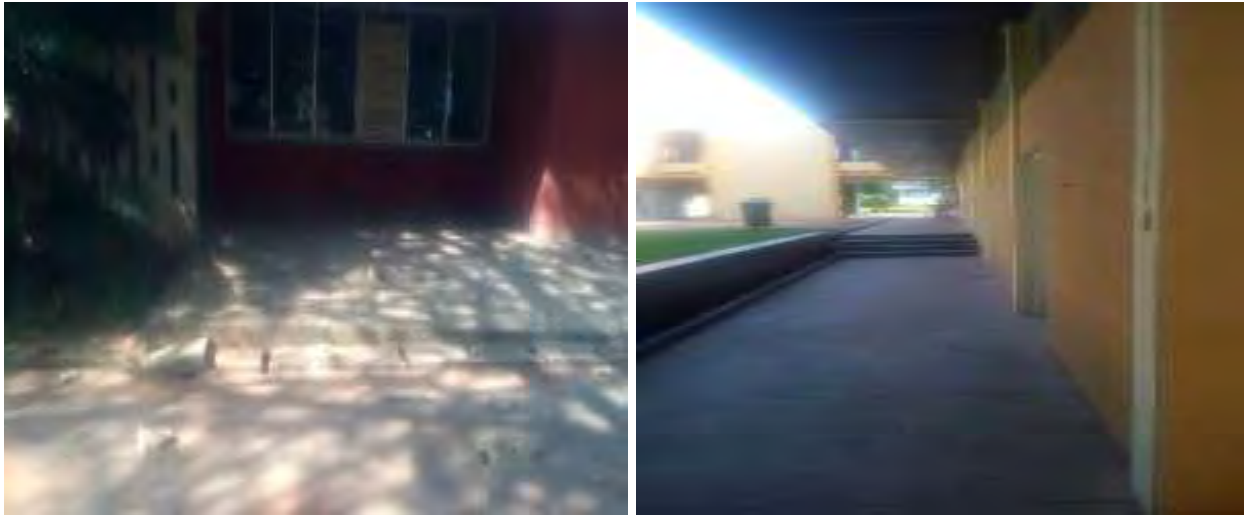
Fig 4.27: The faculty of Architecture building at KNUST, Kumasi lacks provision for the disable at both entrance and corridors (Source: field survey 2018)

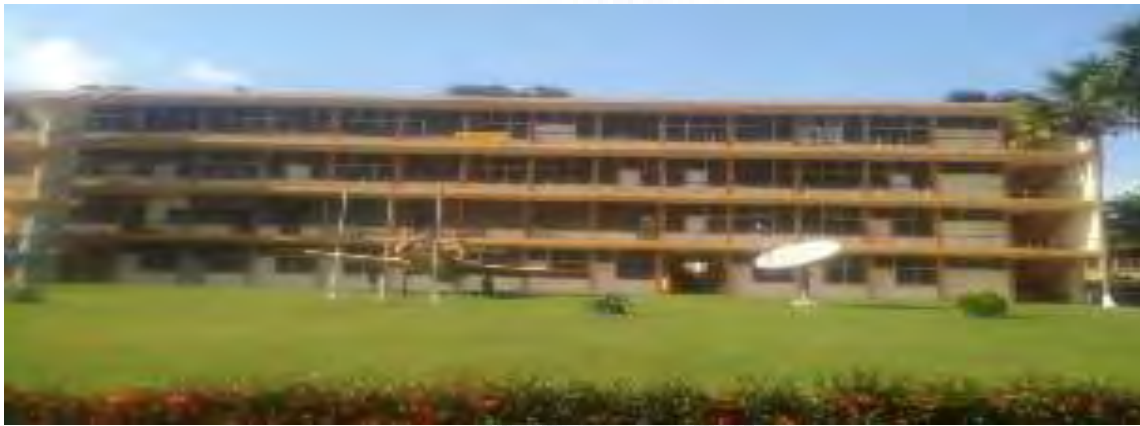
Fig 4.28: College of Engineering building at KNUST, Kumasi Lacks provisions for both horizontal and vertical movement for the disabled . (Source: field survey 2018)

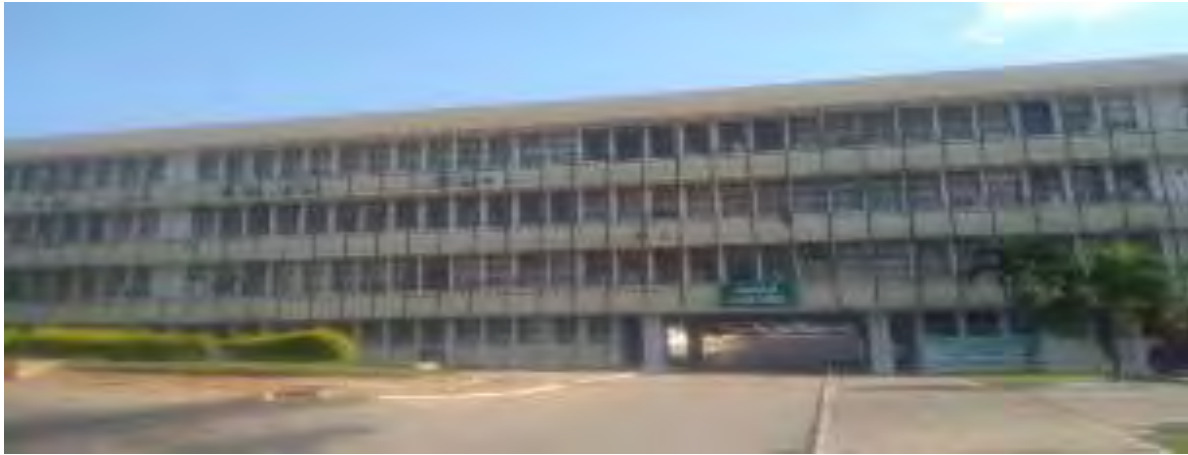
Fig 4.29: Faculty of Pharmacy and Pharmaceuticals Sciences at KNUST, Kumasi Lacks provisions for both horizontal and vertical movement for the disabled. (Source: field survey 2018)

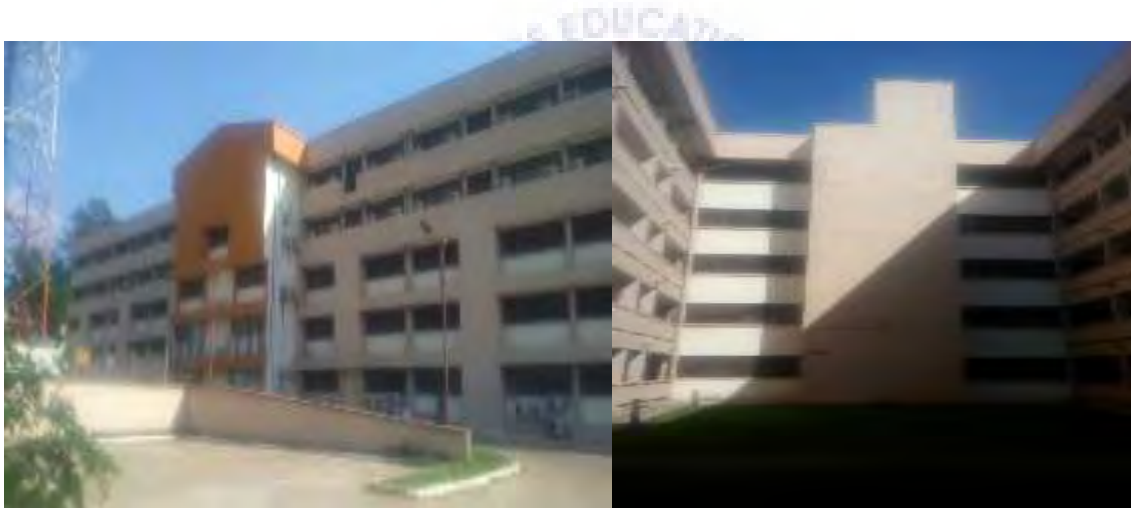
Fig 4.30 Institute of Distance Learning (IDL) building Lacks provisions for both horizontal and vertical movement for the disabled KNUST, Kumasi. (Source: field survey 2018)

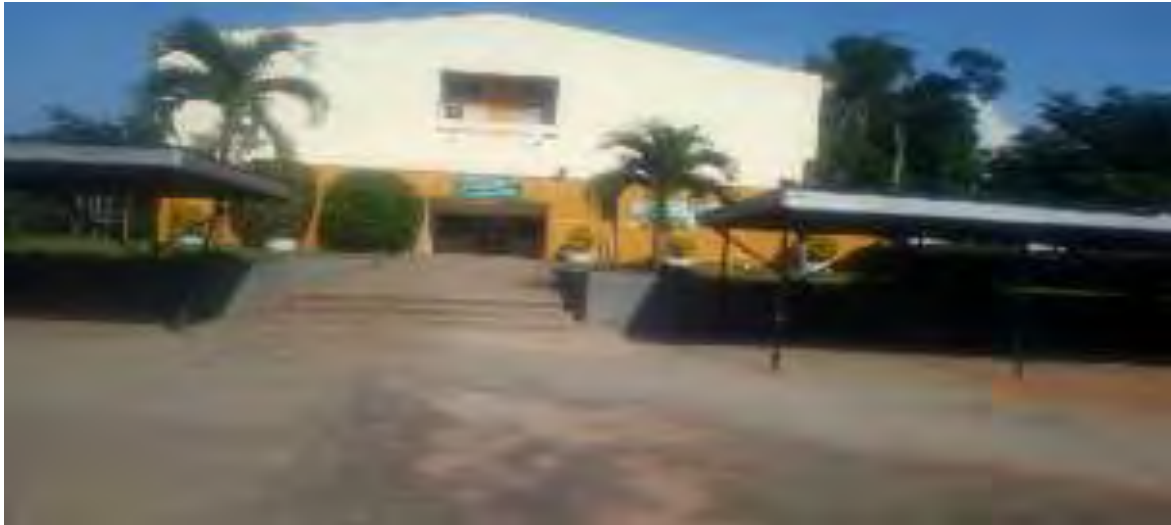
Fig 4.31: Center for drug analysis quality control Kumasi lacks provisions for the disabled at the main entrance. (Source: field survey 2018)
