**ASSESSING THE LEVEL OF COMPLIANCE TO THE BUILT-INFRASTRUCTURE
PROVISIONAL REQUIREMENTS OF THE DISABILITY ACT, 2006 (ACT715)
AMONG PROFESSIONALS WITHIN THE BUILT ENVIRONMENT IN THE KUMASI
METROPOLIS**

MASTER OF PHILOSOPHY

2019

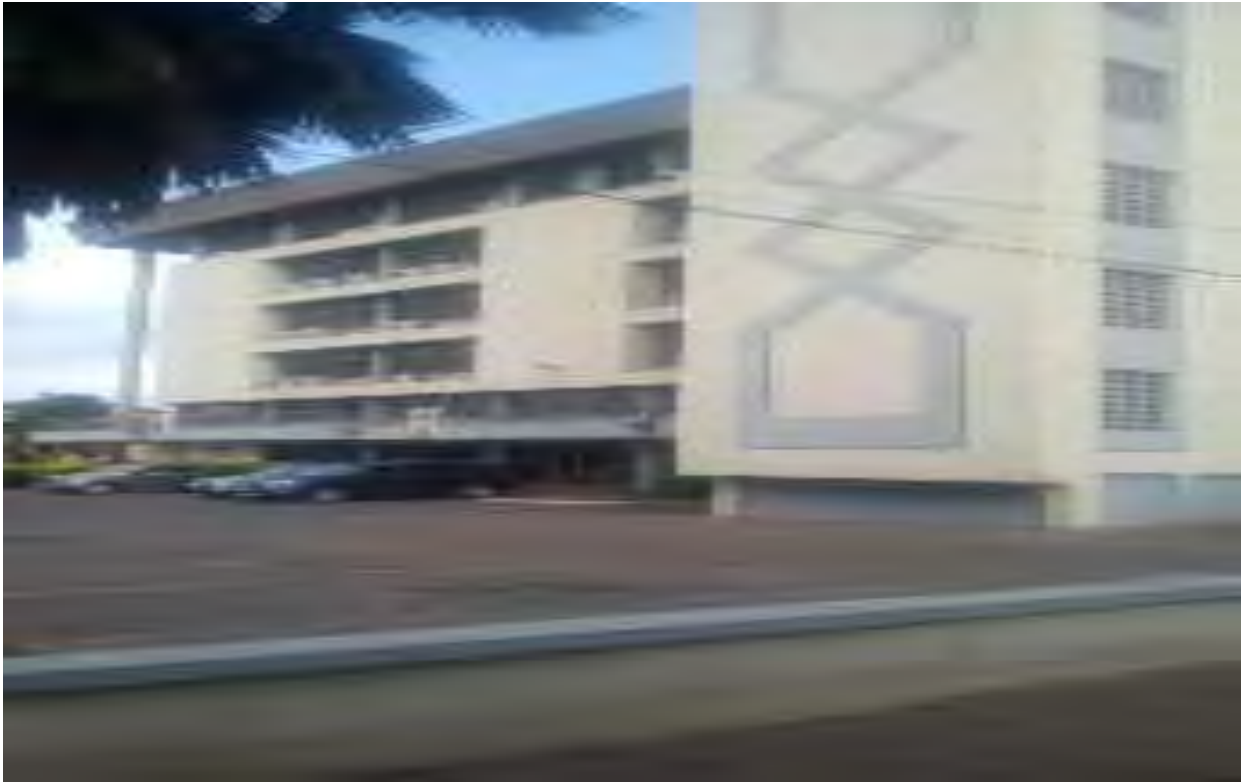
Fig 4.32: The main administration block At KsTU, Kumasi has elevator but lacks provisions for the disable at the entrance and inside the auditorium.

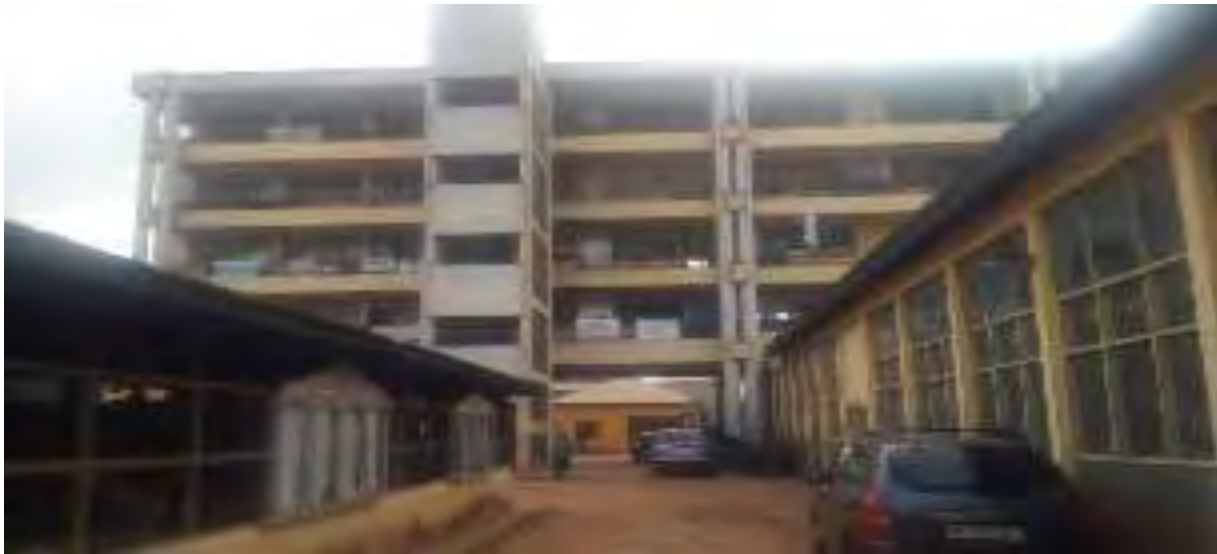
Fig 4.33: The B-tech Block at KsTU, Kumasi lacks provisions for both horizontal and vertical movement for the disabled (Source: field survey 2018)

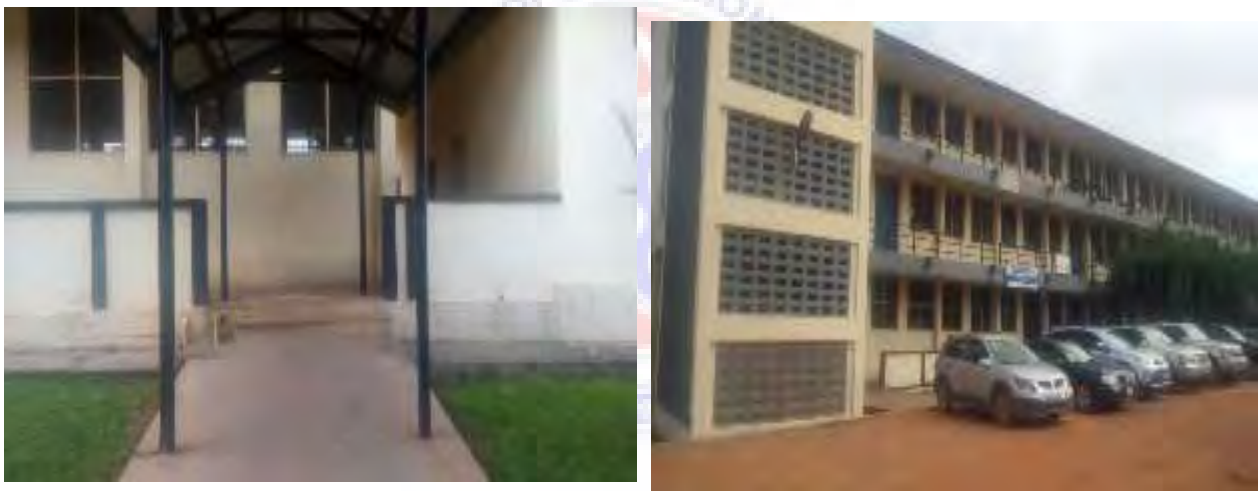
Fig 4.34: lecture blocks A, B and C at KsTU, Kumasi lacks provisions for both horizontal and vertical movement for the physically challenged.

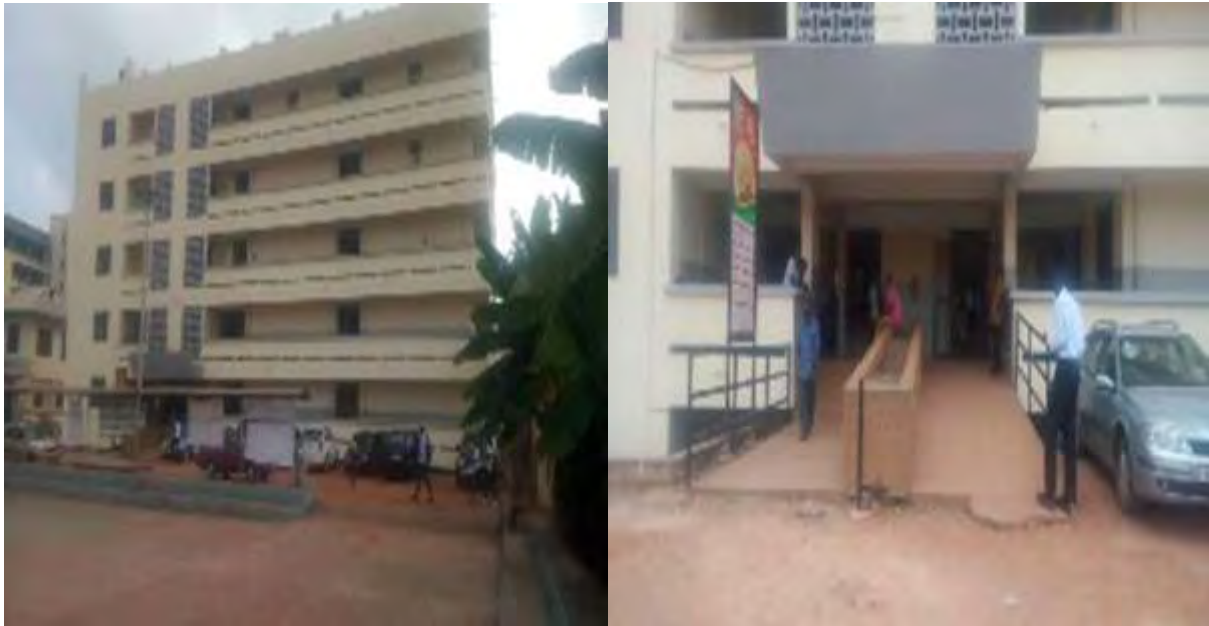
Fig 4.35: The newly constructed MP Block at KsTU, Kumasi has guarded ramp at the entrance but lack those provisions at other parts of the building. (Source: field survey 2018)

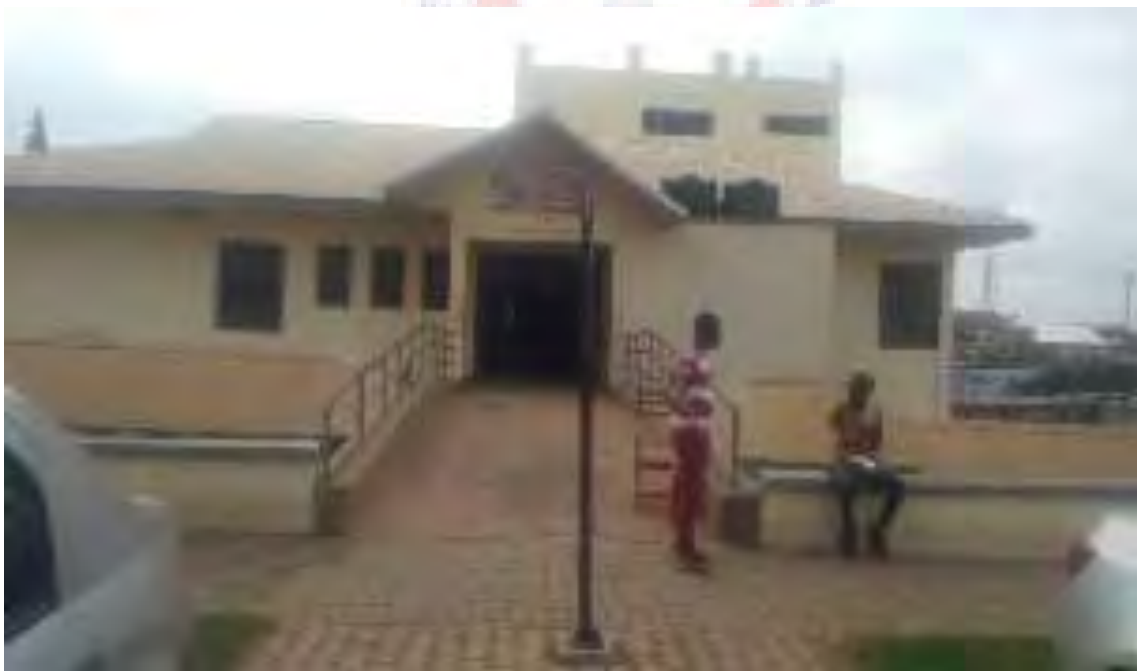
Fig 4.36: This is a newly constructed for Dispensary Technology department At KsTU, Kumasi is disability friendly. (Source: field survey 2018)
