ASSESSING MAINTENANCE CULTURE OF SCHOOL BUILDINGS AND
THEIR IMPACT ON TEACHING AND LEARNING IN PUBLIC BASIC
SCHOOLS IN GHANA: A CASE STUDY IN DENKYEMBOUR DISTRICT IN
THE EASTERN REGION.

SEPTEMBER, 2018

**A dissertation presented to the to the Department of CONSTRUCTION AND
WOOD TECHNOLOGY EDUCATION, Faculty of TECHNICAL
EDUCATION, University of Education, Winneba in partial fulfillment of the
requirements for the award of Degree of Master of (Construction Technology
Education)**

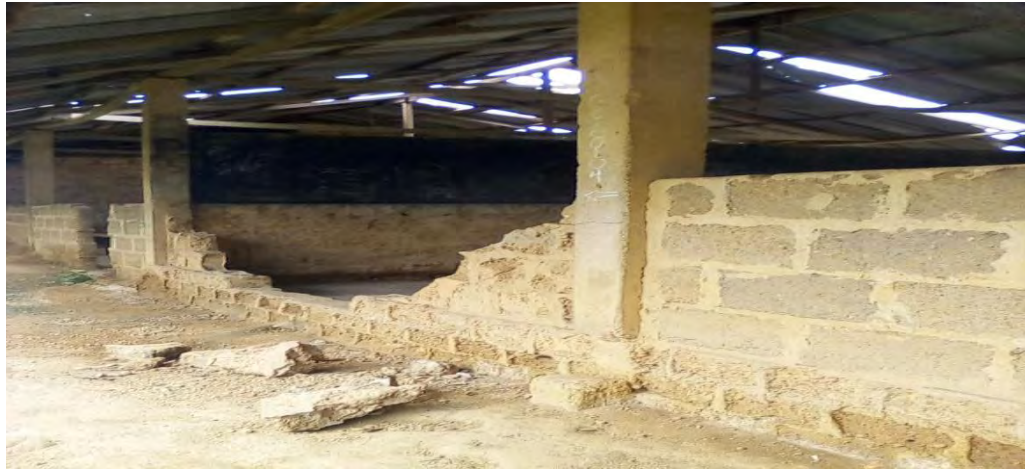
The researcher observed that the school building was built with land create blocks. The internal partition was up the wall plate. The external part of the building was also cladded with land create dwarf wall of which part of the wall has broken down as shown in figure 4.5. The building was not completed before it was put into use, the walls were not rendered to receive paint, the walls were at the mercy of the environment which has caused the walls to deteriorate very fast. The veranda around the building was not floored rendering the whole place dusty.

Figure 4.15 Broken down walls at Akenkanor D/A Basic School

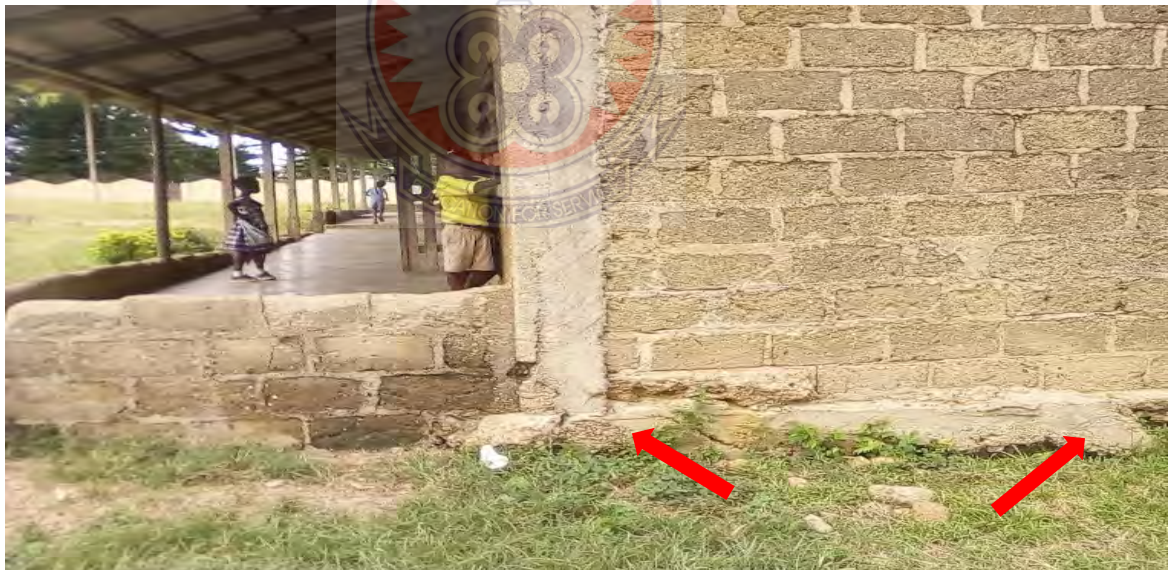
It was observed that the building was not completed before it was used by the students and teachers, the walls of the buildings was not rendered to receive painting. A careful observation of the sand create block wall shows that the weather is having a toll on the wall, it is being eaten away because the walls are not protected by hard surface rendering.

Figure 4.17 Exposed foundation and uncompleted sand Crete wall being eaten away by the weather at Kusi Methodist Basic School

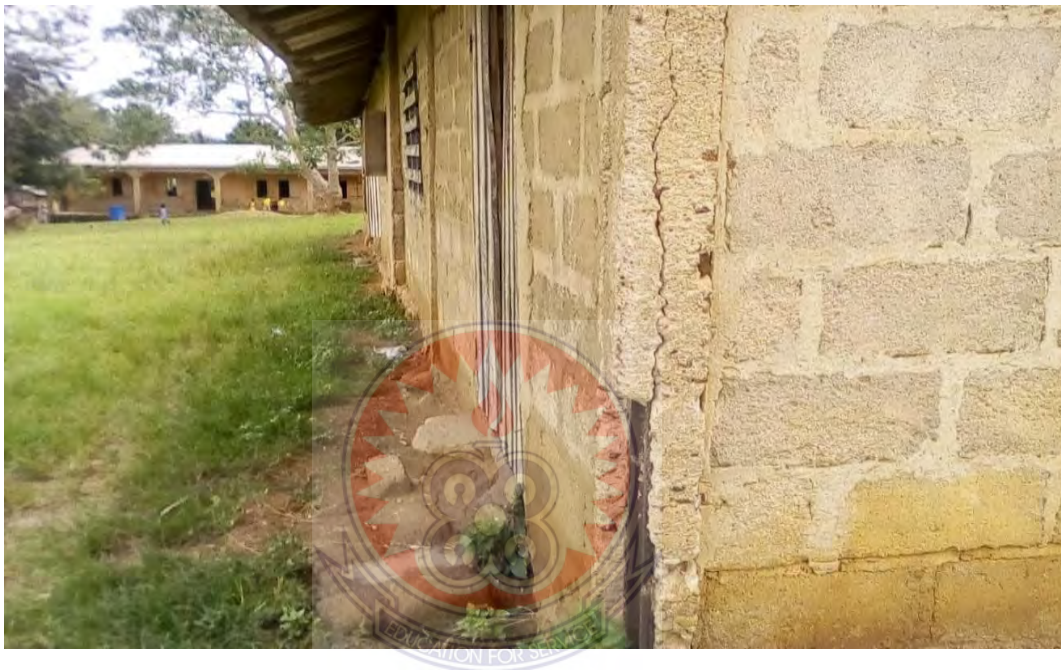
Another observation was also made where cracks were seen at the corner column from the top to the base exposing the reinforcement as indicated in figure 4.18. The reinforcement was seen rusting reducing the strength and the purpose for which it was put there. A close look indicated that the mix proportion of the aggregates were not to required standard.

Figure 4.18 Cracked corner column of Kusi Methodist Basic School exposing the reinforcement.

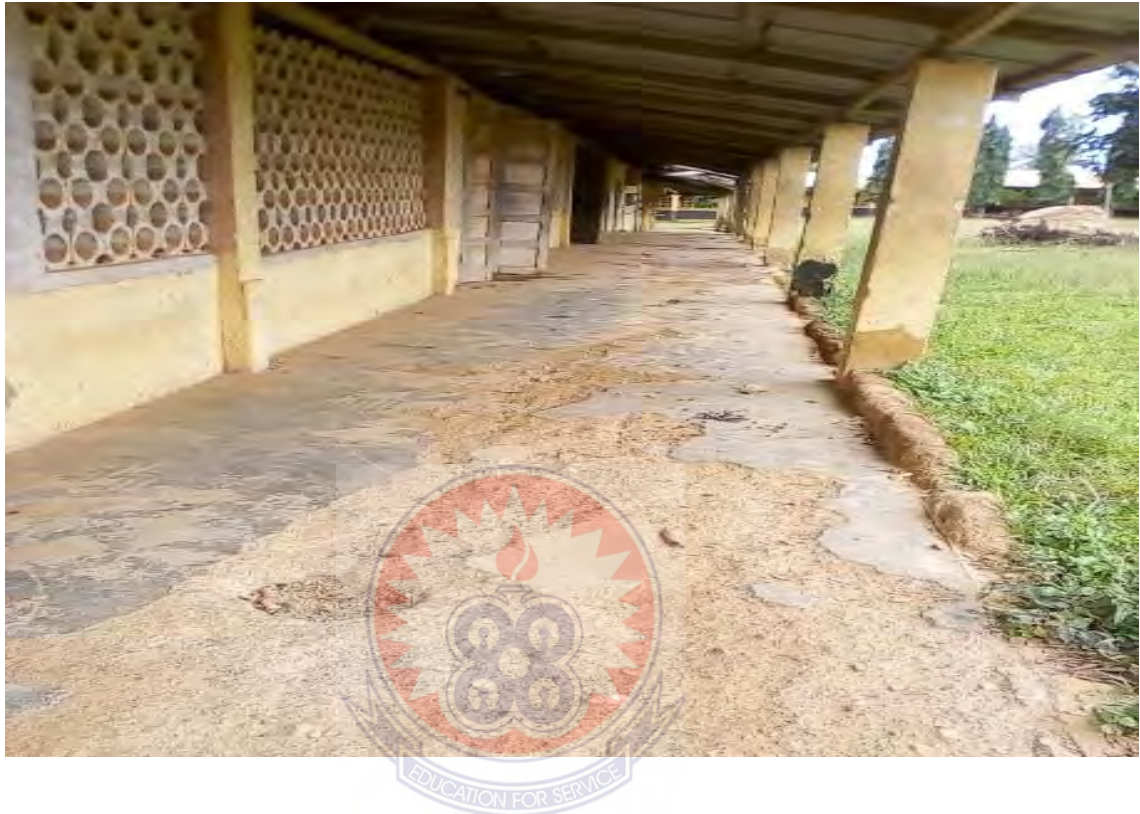
A careful observation of the wearing off of the floor also indicated that the quantity of cement used in the mix did not satisfy the mix ratio, hence the quality of the floor.

Figure 4.19 Wearing off floor at Takrowase R/C Basic School

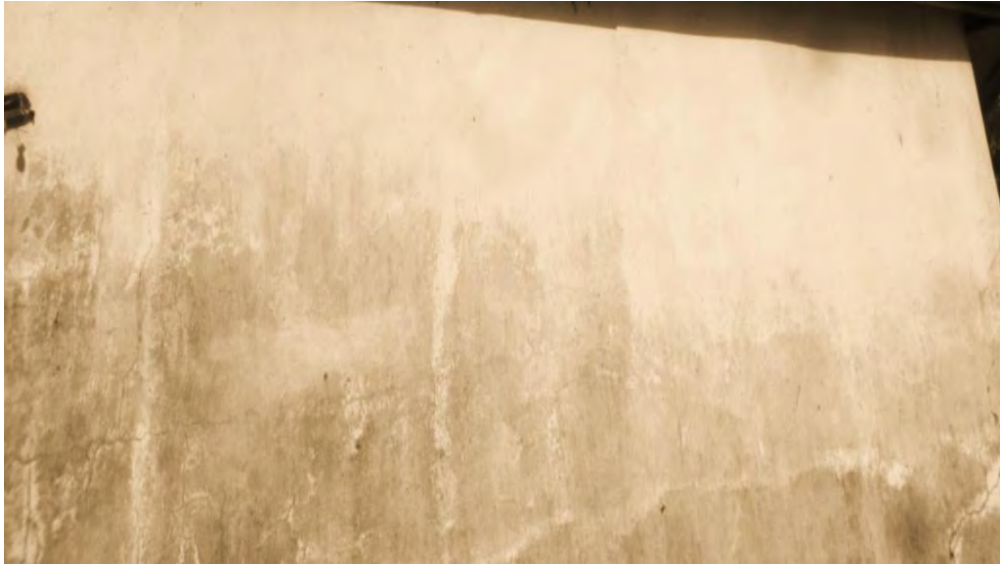
Another close observation of the walls of the School indicated that since the construction of the school building that was painted it has not seen any painting since then. The wall was so dirty that it has destroyed the aesthetics of the building. It is all due to the fact that the wall absorb moisture from the ground during rainy season, again painting is not done regularly. The dirty wall painting is shown in figure 4.20.

Figure 4.20 Wall Painting dirty at Takrowase R/C Basic School

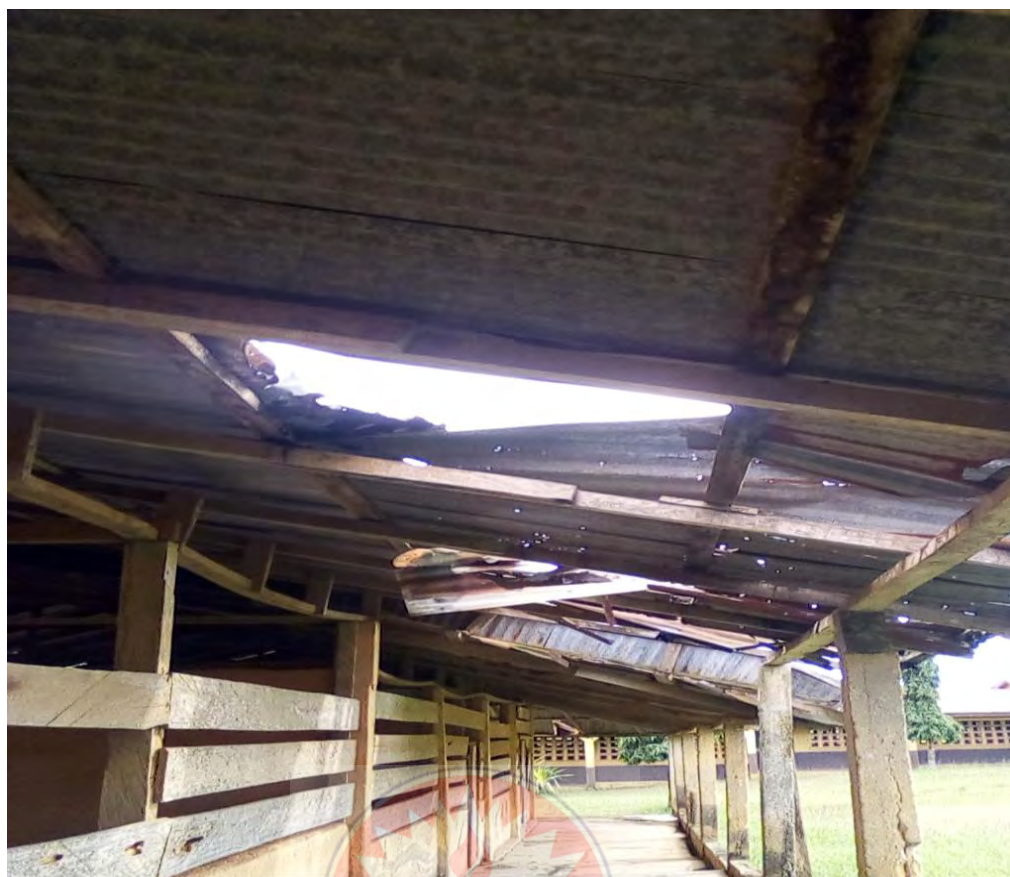
The roof of the Topremang Salvation Army Primary School was critically observed, the roof covering was badly damaged, leaking profusely making the use of the classrooms during rainy season impossible. The rafters and purlins of the roofing are all destroyed due to rain, the nature of the roofing poses danger to the students and teachers. The badly damaged roof is illustrated in figure 4.21, what is pertaining is as a result of lack of maintenance culture.

Figure 4.21 Damaged roofing of Topremang Salvation Army Primary School

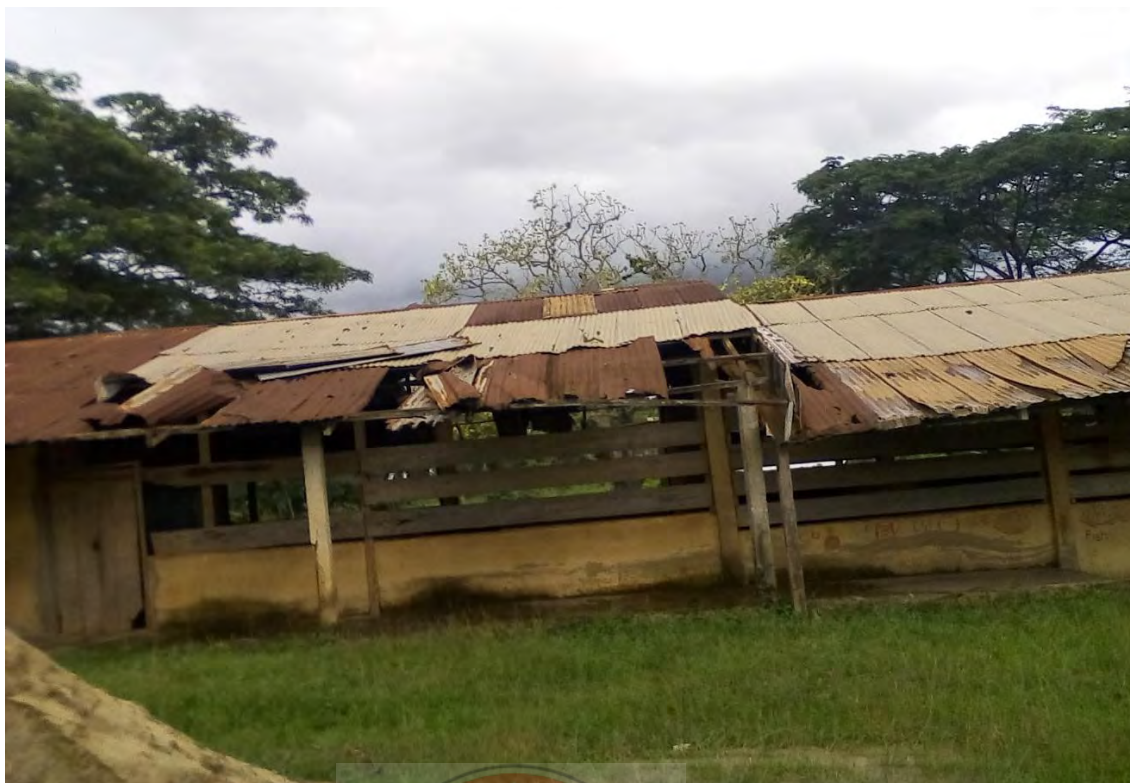
The doors available are almost rotten due the roof leakage. The roofing structure and covering are all in tatters, rain enters the rooms from the roof making the building not fit for human habitation. Due to the rain water which enters the room the wall has absorbed the water disfiguring the wall surface shown in figure 4.22. The condition of the building does not motivate the students to attend school especially during the rainy season. This condition has affected teaching and learning in the school.

Figure 4.22 Topremang Salvation Army Primary School made up of dwarf wall and wooden fencing with tattered roof.

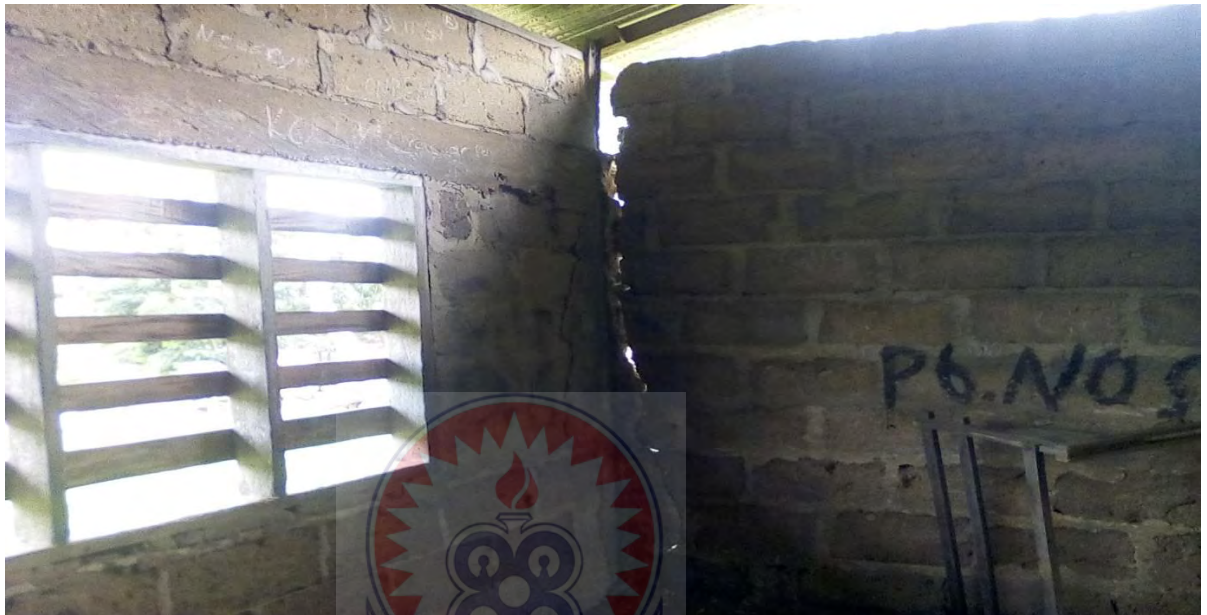
It was detected that the building was not completed before it was used no smooth plastering was given to the walls. The teachers and the students were not motivated to attend school, therefore affecting teaching and learning. Again, this condition has arisen due to lack of routine inspection, maintenance culture and apathetic attitude of the authority concern.

Figure 4.23 Deep crack on wall at Addaekrom D/A Basic School which has separated the two adjacent walls.

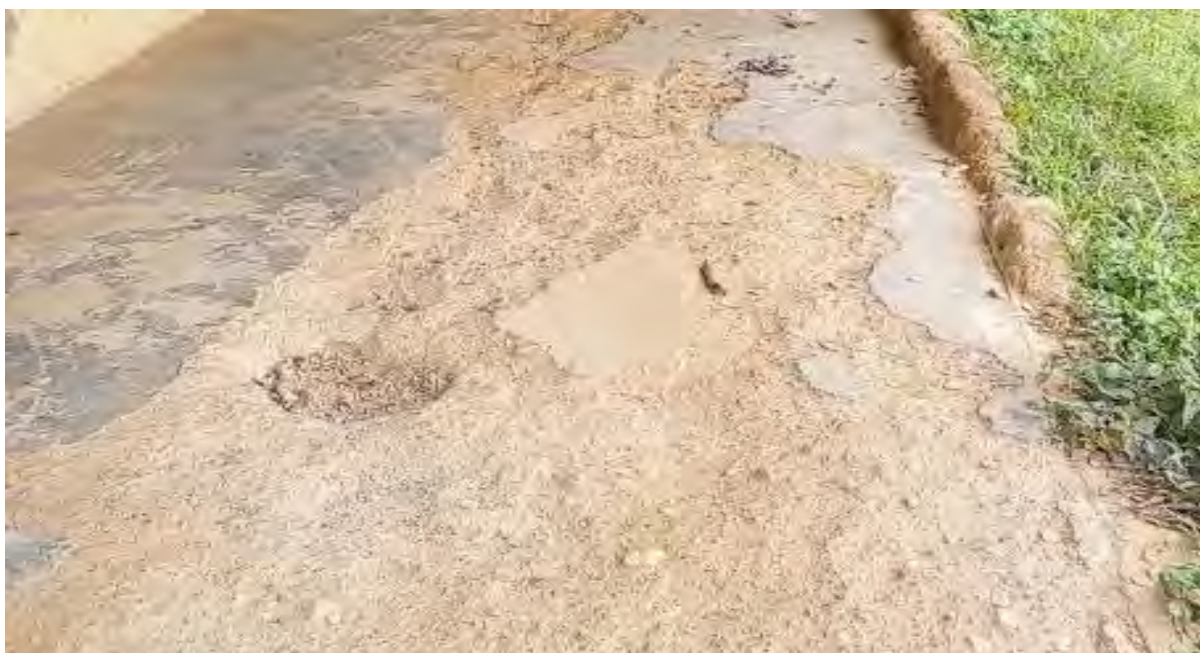
Another observation of the floors of the classrooms made by the researcher identify that the floors of the classrooms were peeled off making the class rooms dusty. This situation came about due to poor workmanship and poor batching of the materials. The badly damaged floor is shown in figure 4.24

Figure 4.24 Peeled off screed and wearing off floor at Addaekrom D/A Basic School

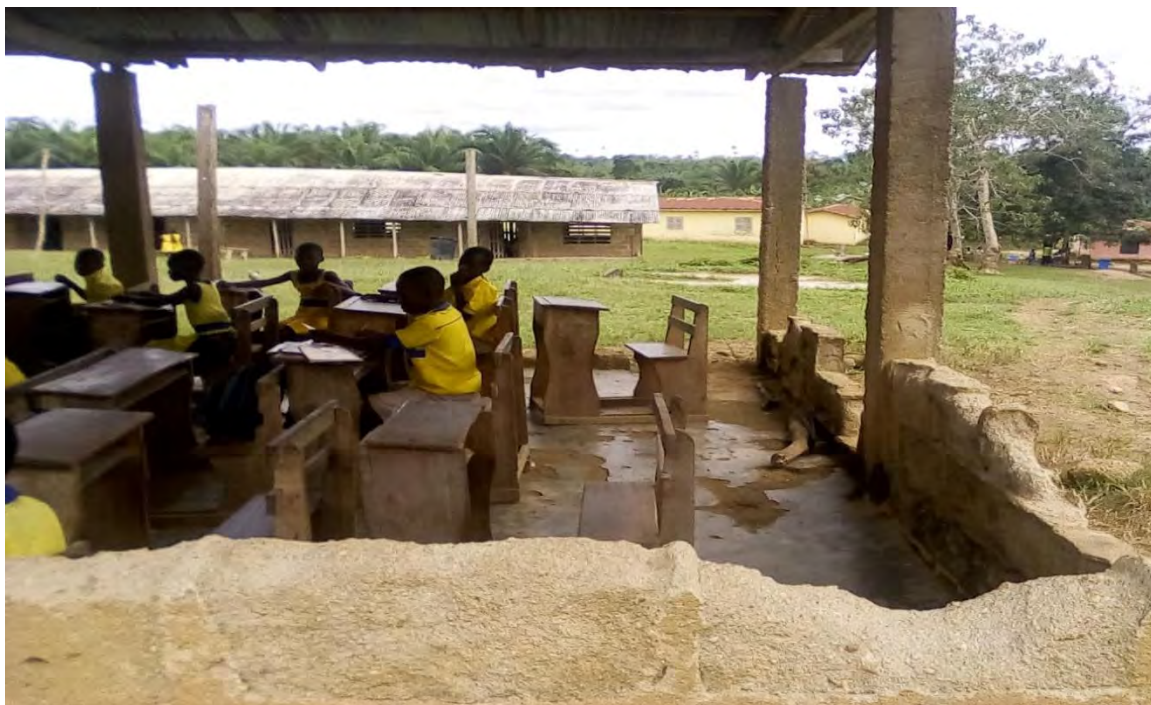
During the visit the researcher saw that the walls around the classroom block were all collapsed due to uncompleted construction of the walls. There were no doors or windows. Due to these stray animals use the classrooms as their domicile. During harsh weather conditions it affect the students class attendance, therefore affect teaching and learning. The situation is as indicated in figure 4.25, the school building was not completed before it was used by the students and the teachers.

Figure 4.25 Collapsed walls of Akim Wenchi Methodist Basic School

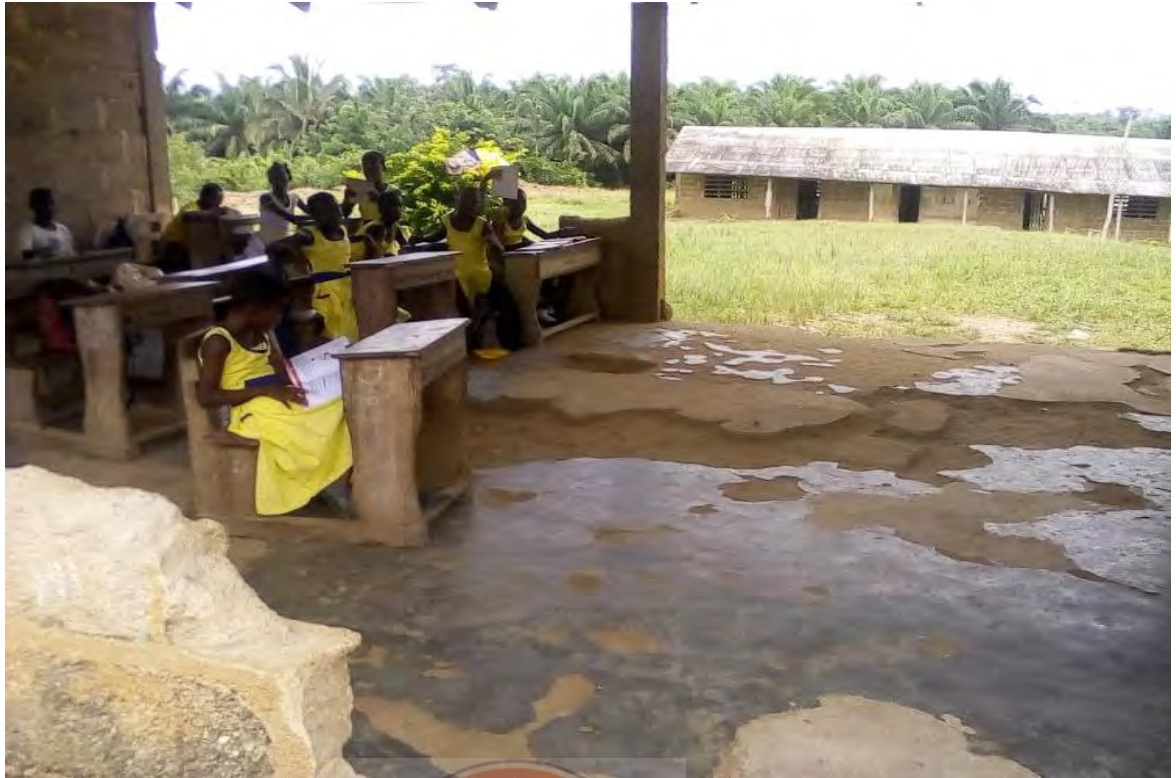
Another observation that was made by the researcher was the floor of the classroom which has peeled off. There were deep holes on the floor of the classroom which was being used by the students. The badly damaged floor of the school is as shown in figure 2.26, the situation was due to the fact that workmanship was very poor and the required mix ratio was not used. Again the situation came about as a result of poor maintenance culture on the part of the authorities concern.

Figure 4.26 Peeled off floor of Akim Wenchi Methodist Basic School
